## U. S. PUBLIC LAND SURVEY MONUMENT RECORD

Section Corner to Sections 28 and 33, T.34N., R.14E., Forest County, Wisconsin.

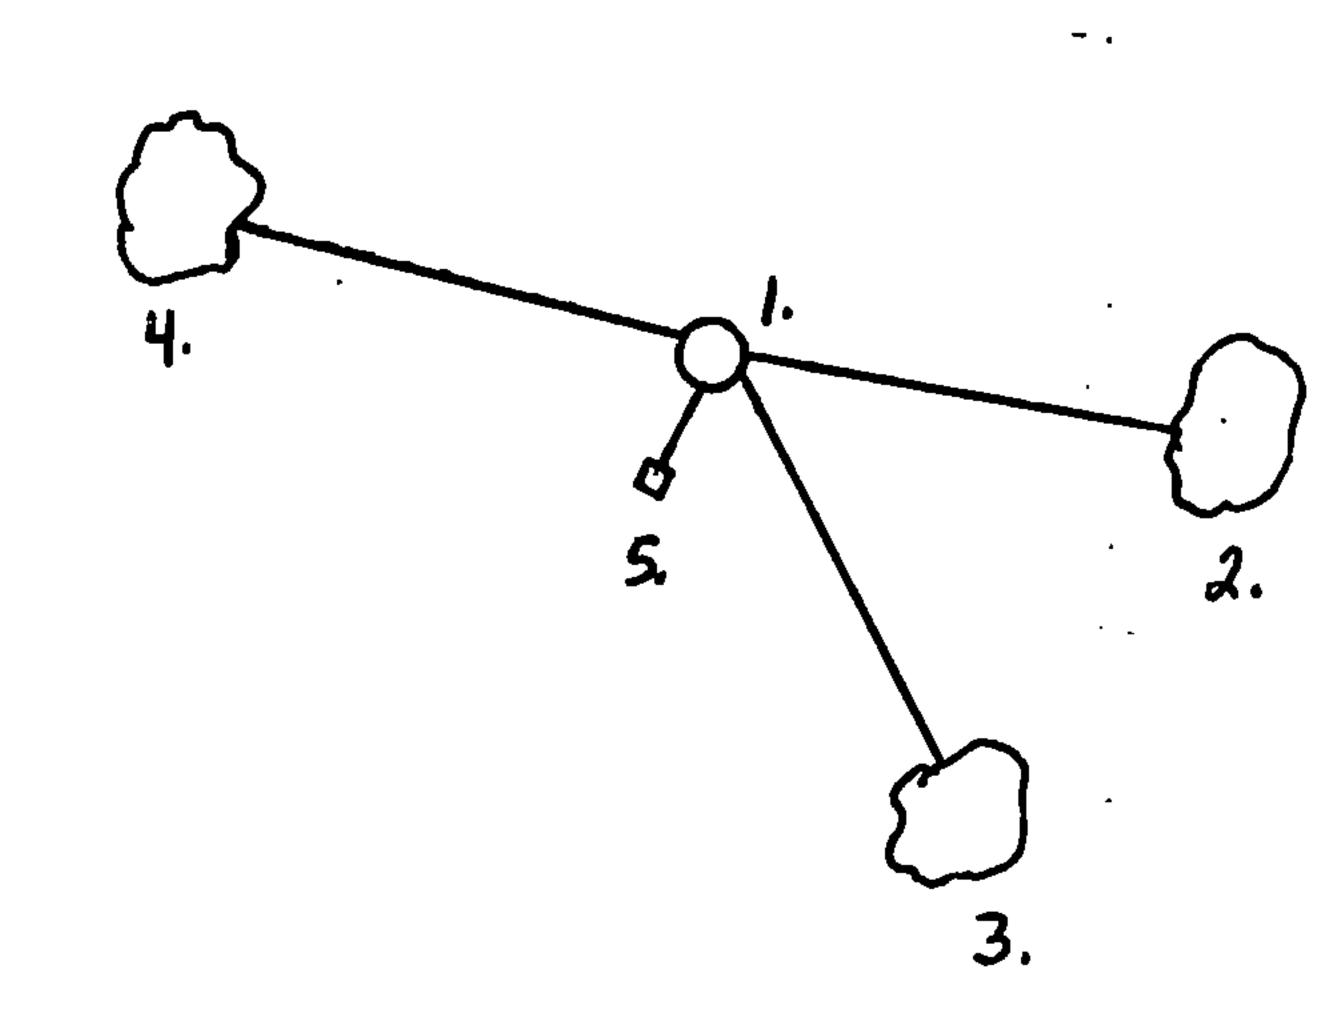
- (c) In the plan view drawing below, provide reference ties to at least 4 witness monuments, or, if the location is within a municipality, to at least 2 witness monuments. (witness monuments shall be made of concrete, natural stone, iron orother equally durable material.)
- (d) Show a plan view drawing depicting the relevent monuments and reference ties which is sufficient in detail to enable accurate relocation of the corner monument if the corner monument is disturbed. Indicate north.
  - 1. Forest County Monument
  - 2. Maple, 9", S.76°E., 22.80 feet.
  - 3. Maple, 12", S.44°E., 22.29 feet.
  - 4. Maple, 17", N.74°W., 24.80 feet.
  - 5. Steel Sign Post, Southwest, 1.70 feet.

( e )	Describe any material discrepancy between the location of the corner as restored or reestablished and the location of that corner as previously restored or reestablished by distance and direction. Show the discrepancy on the plan view drawing under (d). above. Show the distances between the corner as previously restored or reestablished				
	and (1) the corner as restored or r monuments shown on the drawing in (	eestablished.			
	None.		•
