U. S. PUBLIC LAND SURVEY MONUMENT RECORD

Section corner to Sections 10, 11, 14, and 15, T.34N., R.16E.

Section Corner to Sections 10, 11, 14 & 15; T.34N., R.16E., 4th P.M.

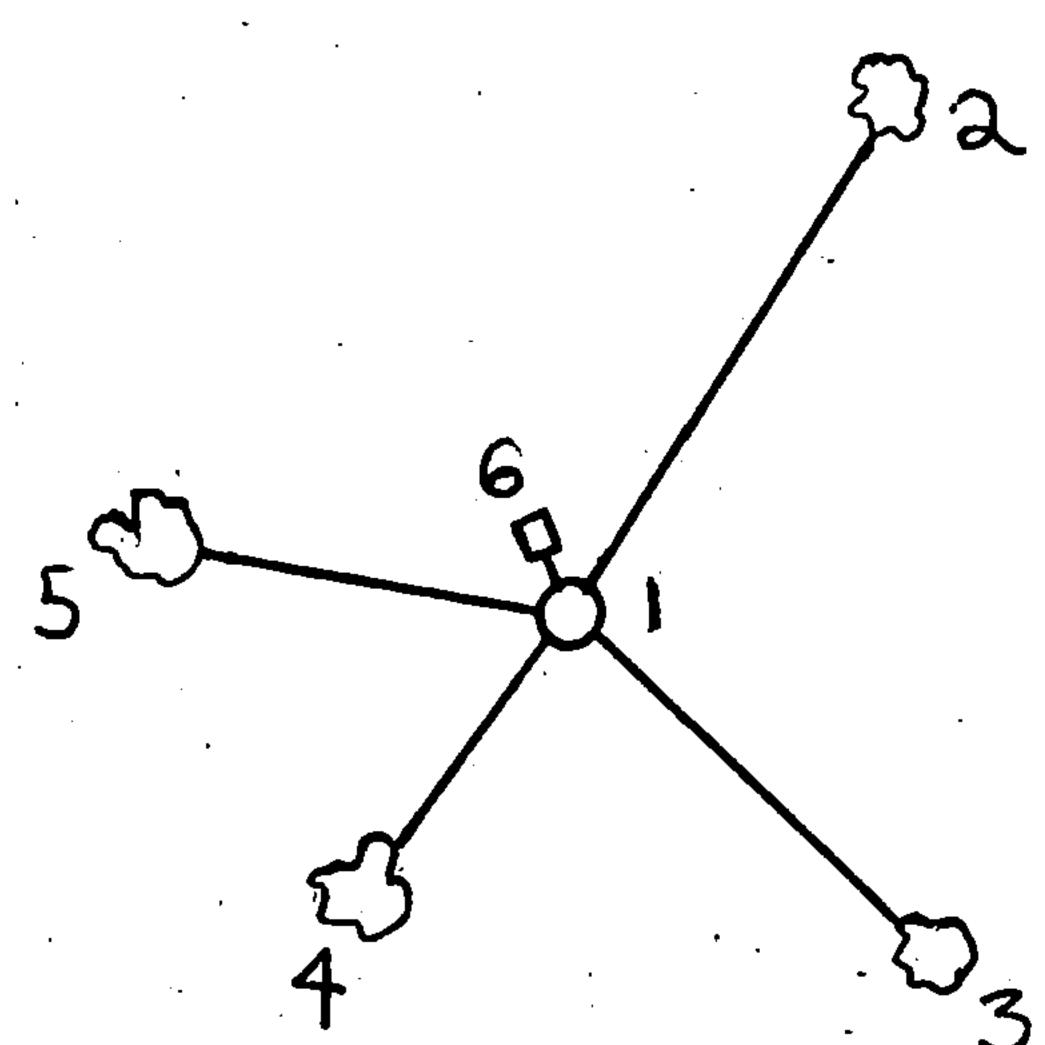
In 1858, James McBride set wood post with the following BTs: Tamarack, 14", N.20°W., 57 links; Tamarack, 12", N.29°E., 20 links; Black Ash, 12", S.44°E., 30 links; Birch, 16", S.11°W., 17 links.

January, 1984, Milo Stefan, Bay Shore Farm Road runs north and south from section corner. Found no evidence of fence line or corner position.

Describe witness monuments.
- (d) Show a plan view drawing depicting the relevant monuments and reference ties which is sufficient in detail to enable accurate relocation of the corner monument if the corner monument is disturbed. Indicate north.
- 1. A 2" x 36" aluminum monument stamped to identify the corner.
- 2. Tamarack, 5", N.25°E., 88.68'
- 3. Aspen, 6", S.39°E., 68.32'
- 4. Tamarack, 14", S.38°W., 44.44'
- 5. White Spruce, 7", N.86°W., 36.73'
- 6. Steel Sign Post, Northwest, 0.7'

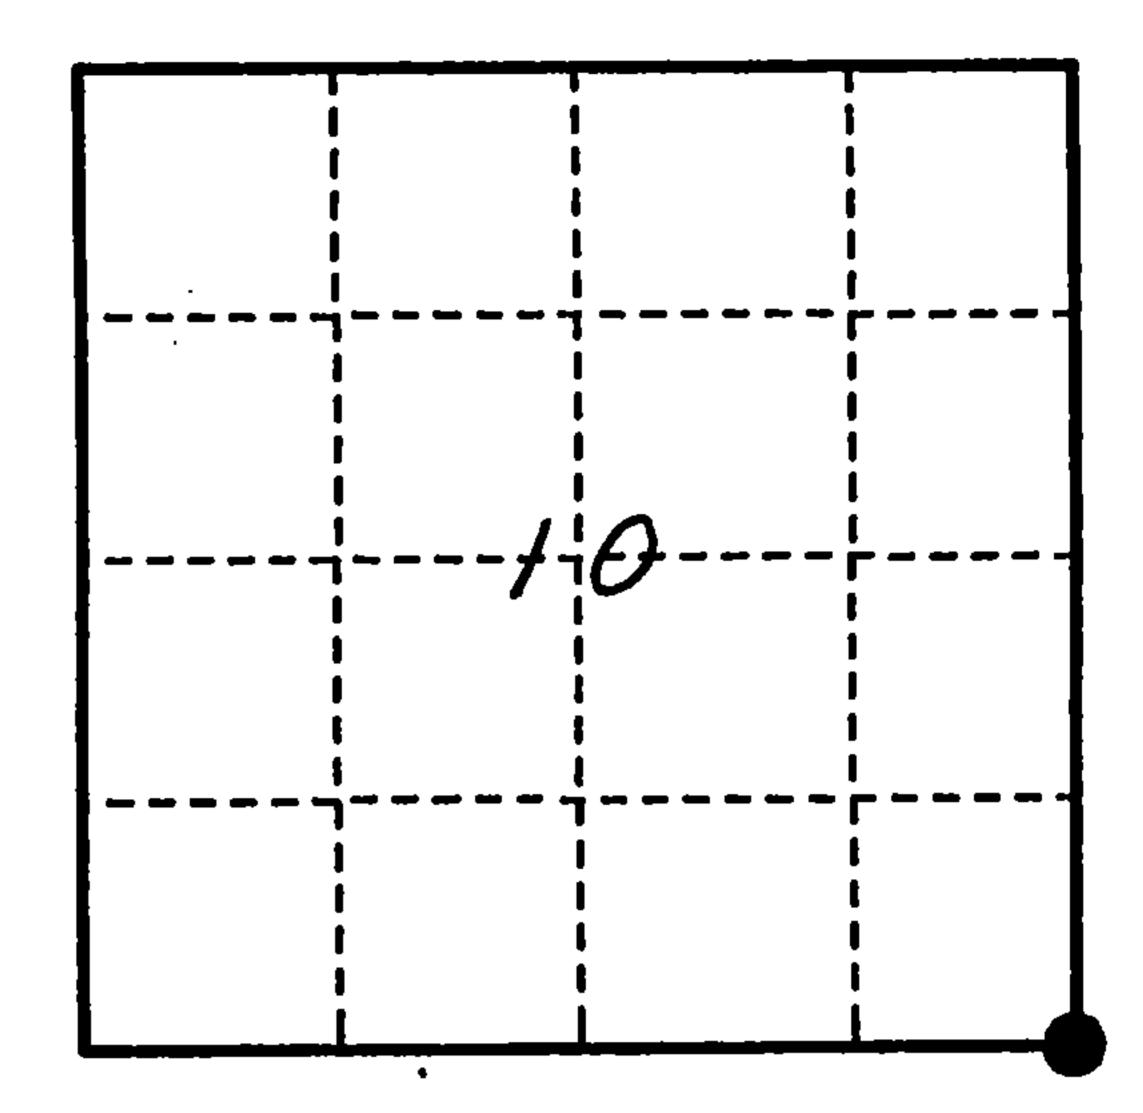
Found aluminum monument, sign post and two BTs in good condition. Aspen and 5" Tamarack dead and down. This corner was restored by myself in 1983.

Black Spruce, 6", S.15°E., 123.04' White Pine, 6", S.3°W., 139.59'

- (d) Show a plan view drawing depicting the relevent monuments and reference ties which is sufficient in detail to enable accurate relocation of the corner monument if the corner monument is disturbed. Indicate north.
 - 1. 2" Aluminum monument.
 - 2. Black Spruce, 6", S.15°E., 123.04'.
 - 3. White Pine, 6", S.3°W., 139.59'.
 - 4. Tamarack, 14", S.38°W., 44.44'.
 - 5. White Spruce, 7", N.86°W., 36.73'.
 - 6. Steel sign post, Northwest, .70'.
