CERTIFIED LAND CORNER RESTORATION

Township 35 North, Range 15 East, Section 12, Index No. E-25, Page No.

U. S. PUBLIC LAND SURVEY MONUMENT RECORD

Section Corner to Sections 1, 6, 7 and 12,
 T.35N., R.15 - 16 E., Forest County, Wisconsin.

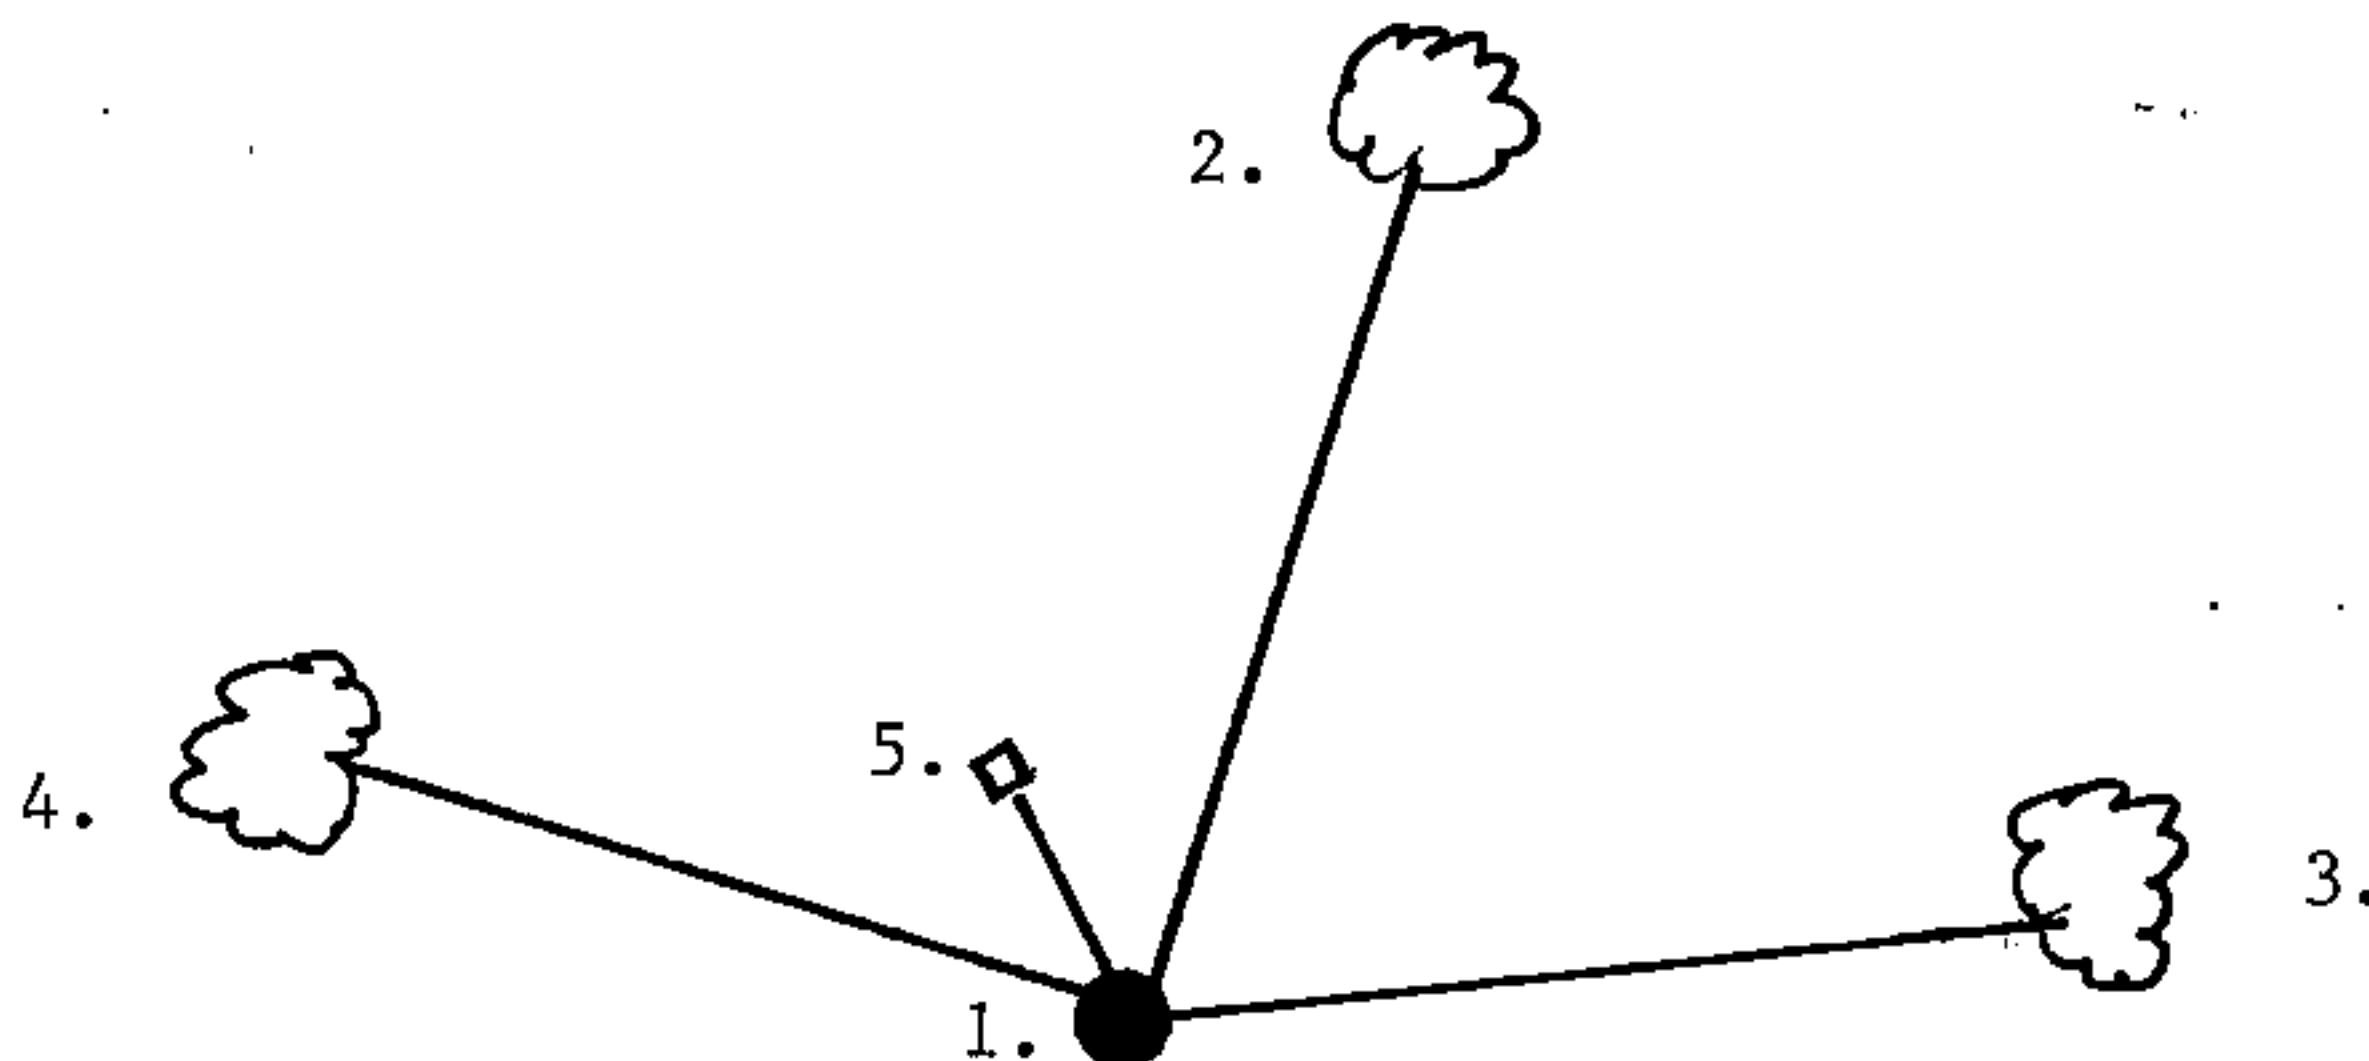
1. 2" X 60" iron pipe with brass cap stamped to identify corner.
2. Cedar, 13", N.16°E., 62.50 feet.
3. Cedar, 10", N.78°E., 50.05 feet.
4. Cedar, 9", N.65°W., 57.40 feet.
5. Steel Sign Post, Northwest, 2.00 feet.
