U. S. PUBLIC LAND SURVEY MONUMENT RECORD

Section corner to Sections 20-21-28-29, T.37N., R15E., Forest County.

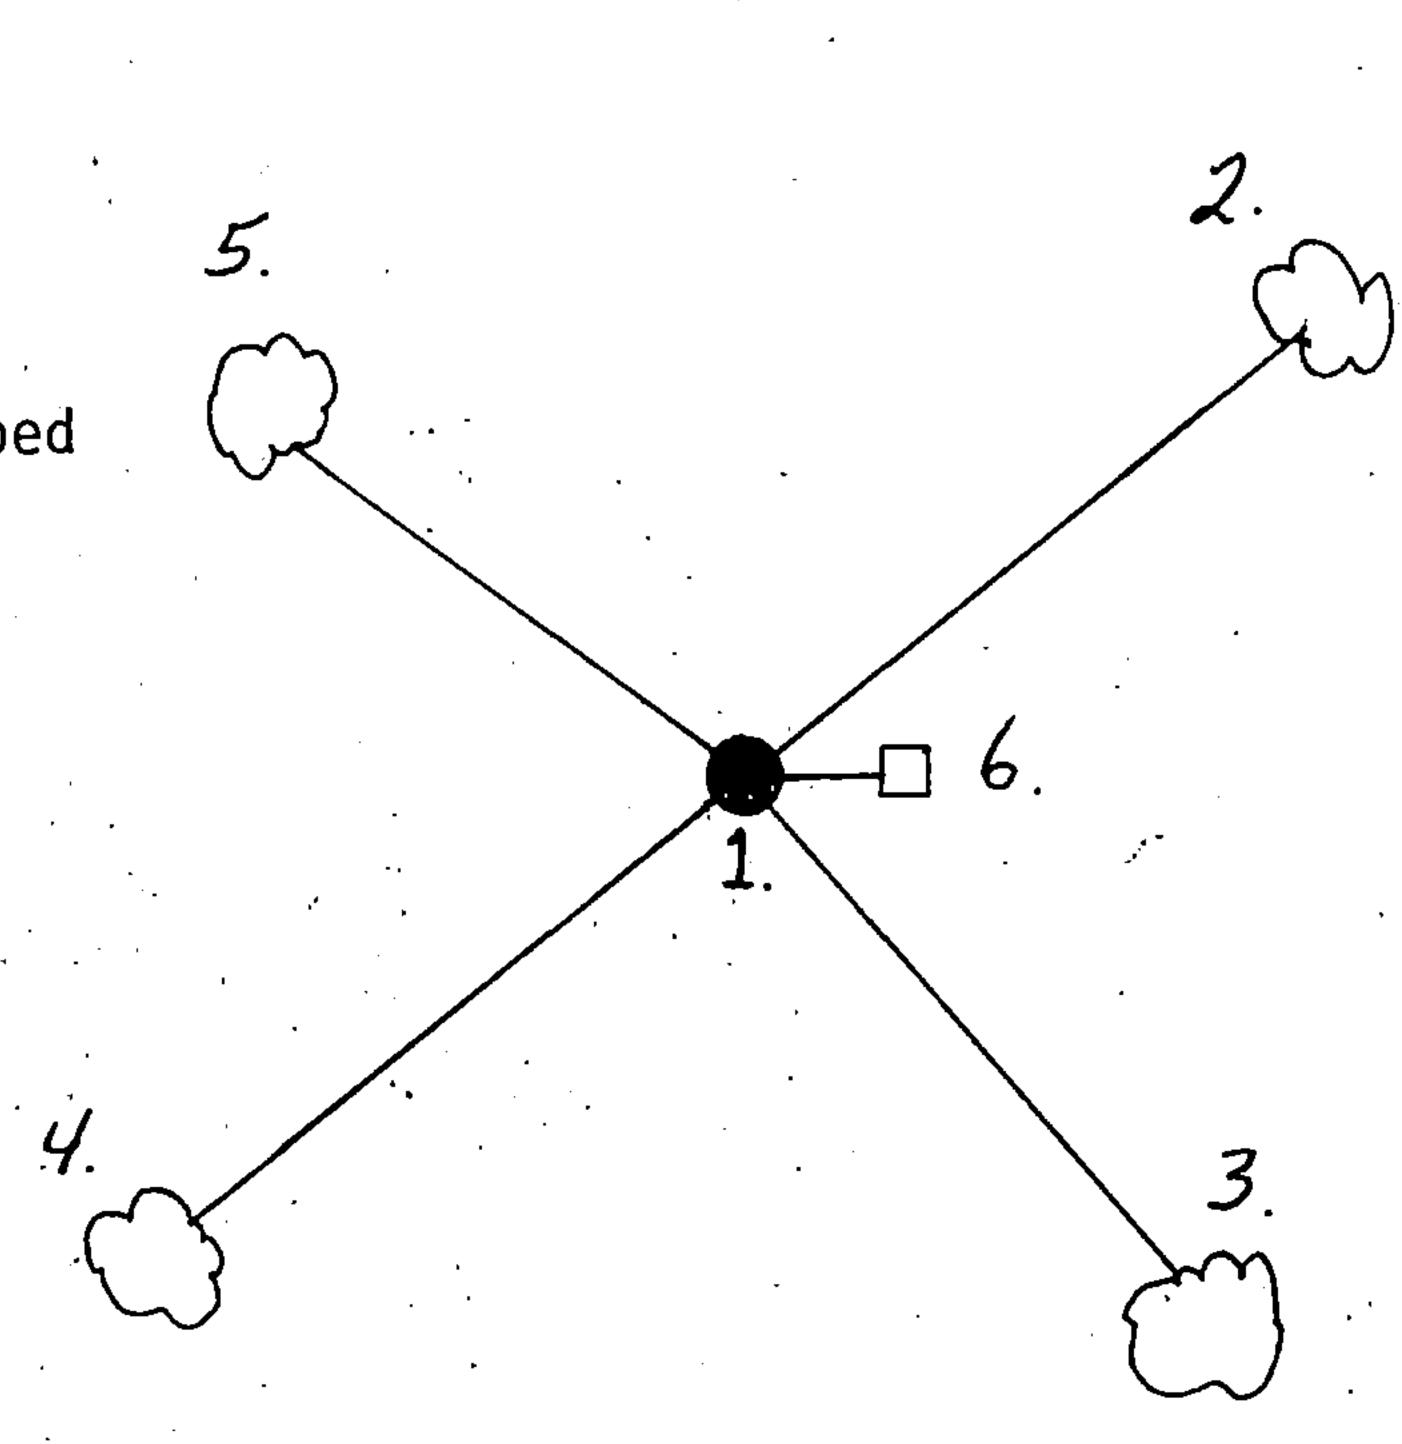
In 1988, Al Harrison found monument bent over and broken. Replaced and added new BTs.

Describe witness monuments.
- (d) Show a plan view drawing depicting the relevant monuments and reference ties which is sufficient in detail to enable accurate relocation of the corner monument if the corner monument is disturbed. Indicate north.
 - 1. A $2\frac{1}{2}$ " x 36" aluminum monument with cap stamped to identify the corner.
 - 2. Tamarack, 8", N.59E., 53.62 feet.
 - 3. Spruce, 6", S.44E., 44.27 feet.
- 4. Tamarack, 6", S.58W., 44.12 feet.
- 5. Tamarack, 7", N.62W., 40.03 feet.
- 6. Steel Sign Post, East, 10.89 feet.
