CERTIFIED LAND CORNER RESTORATION

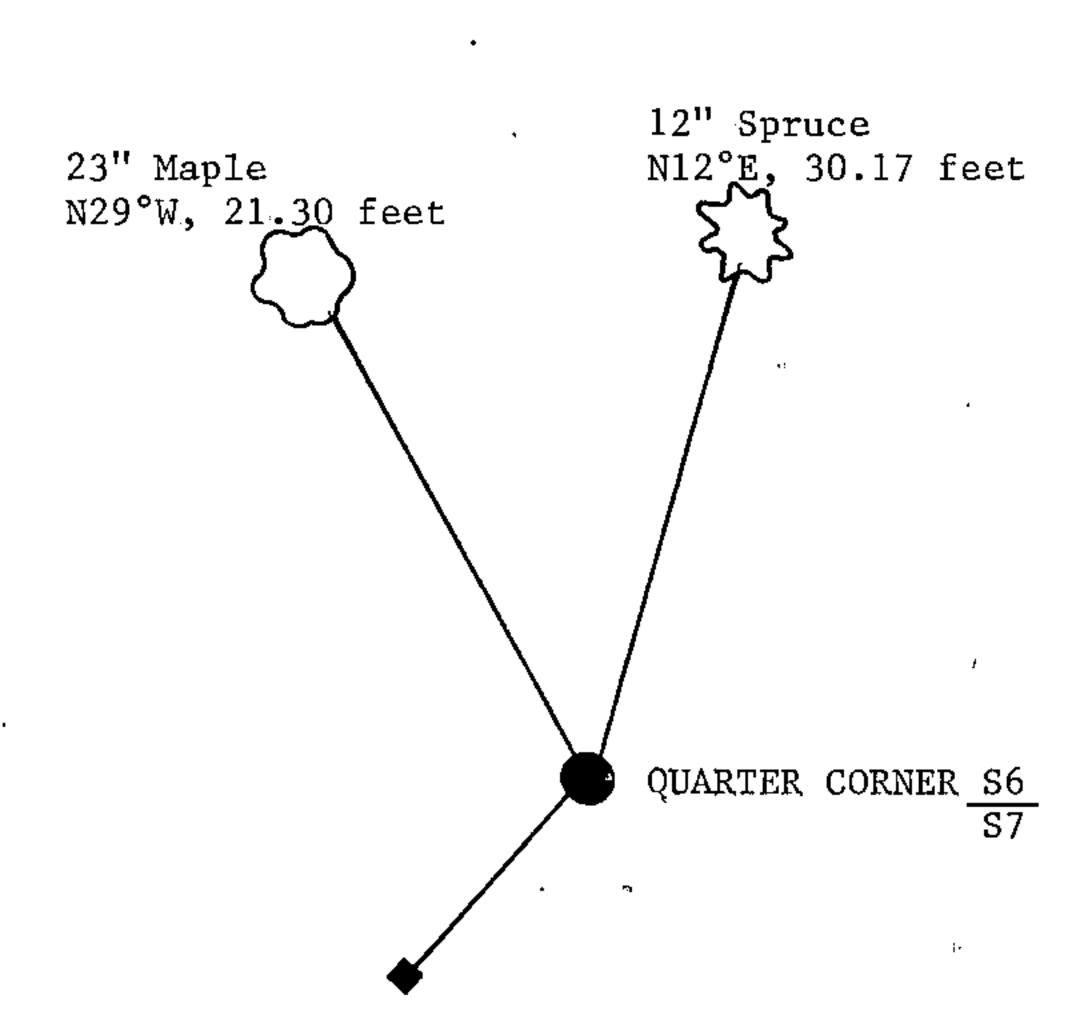
Found monument as described above, and the following bearing trees;

Maple	23"	N29°W	21.30 feet
Maple(DEAD)	16 ''	S73°W	28.90 feet
Iron Post	* I'	Southwest	1.00 feet

Iron Sign Post Southwest, 1.00 feet

Description of monument and accessories I established to perpetuate the original location of this corner. Blazed and scribed a new bearing tree;

Spruce

N12°E

30.17 feet

Re-painted existing bearing trees and Iron Sign Post.
