LANGLADE COUNTY U.S. PUBLIC LAND CORNER RESTORATION

The quarter corner common to Sections 19 & 20, T. 33 N., R. 13 E., Langlade County, WI.

PLSS field condition report

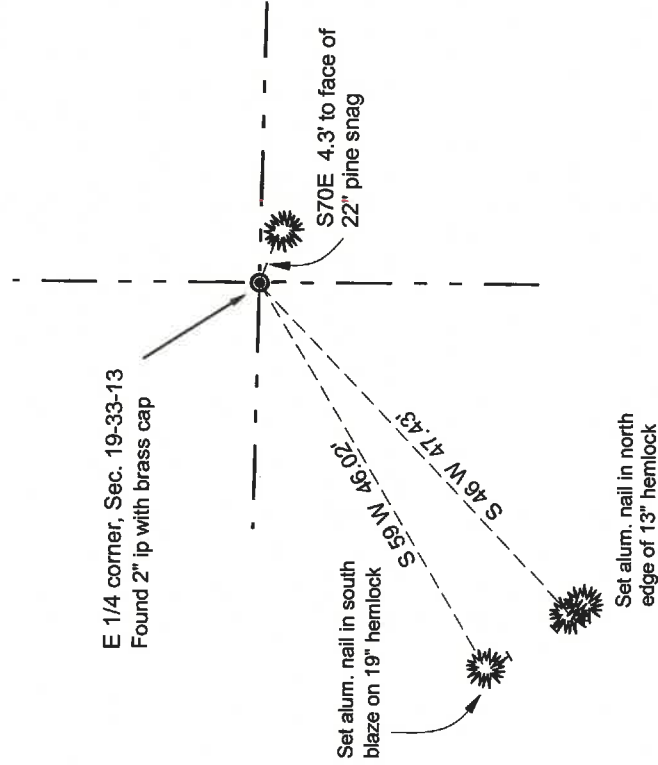
The original corner was established in 1865 by James Nowlin. Original bearing trees: sugar, 15", S66E, 75 lks and a sugar, 8", N66W, 30 links. In 1977, Ray Hallisy found a 1" axle that he said was set by Hutchinson in 1928. He replaced the axle with a 2" iron pipe with brass cap and marked three new BT's (1 white pine and 2 hemlocks). On Nov. 30, 2016, Luke Williams and I found Hallisy's pipe and his hemlocks green and his pine now a snag. Left existing monument in place and measured references as shown below.

I found the existing monument in good condition and left it as found.
I set a 6' steel channel post with sign, 0.65 ft west of corner monument.

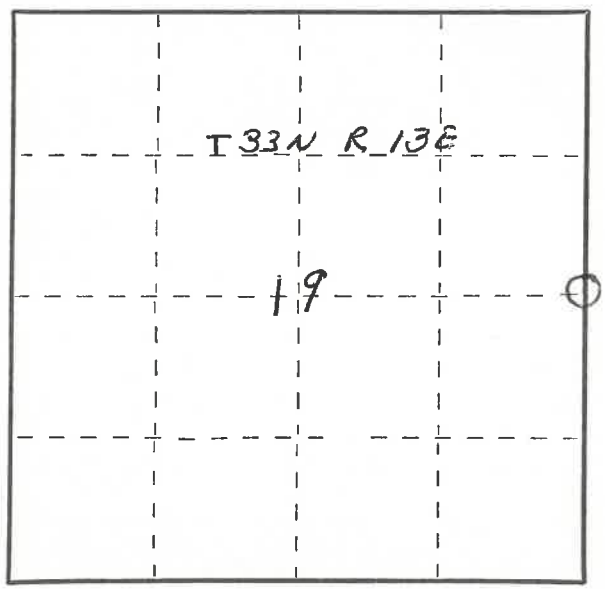
Description of corner evidence found:
1" Axle for corner
4"x4" scribed cedar post 10" south of axle
old B.T.
Pine stump 558W 11'3"

Description of monument and accessories I established to perpetuate the original location of this corner.
Set 2" IRON PIPE WITH BRASS CAP IN PLACE OF AXLE
New B.T.'s
White pine 22" S75E 4'3"
Hemlock 14" S41W 47'6"
Hemlock 14" S45W 45'9"
