# LANGLADE COUNTY

**U.S. PUBLIC LAND CORNER RESTORATION**

The Southeast corner of Section 15, T. 32 N., R. 10 E., Langlade County, WI.

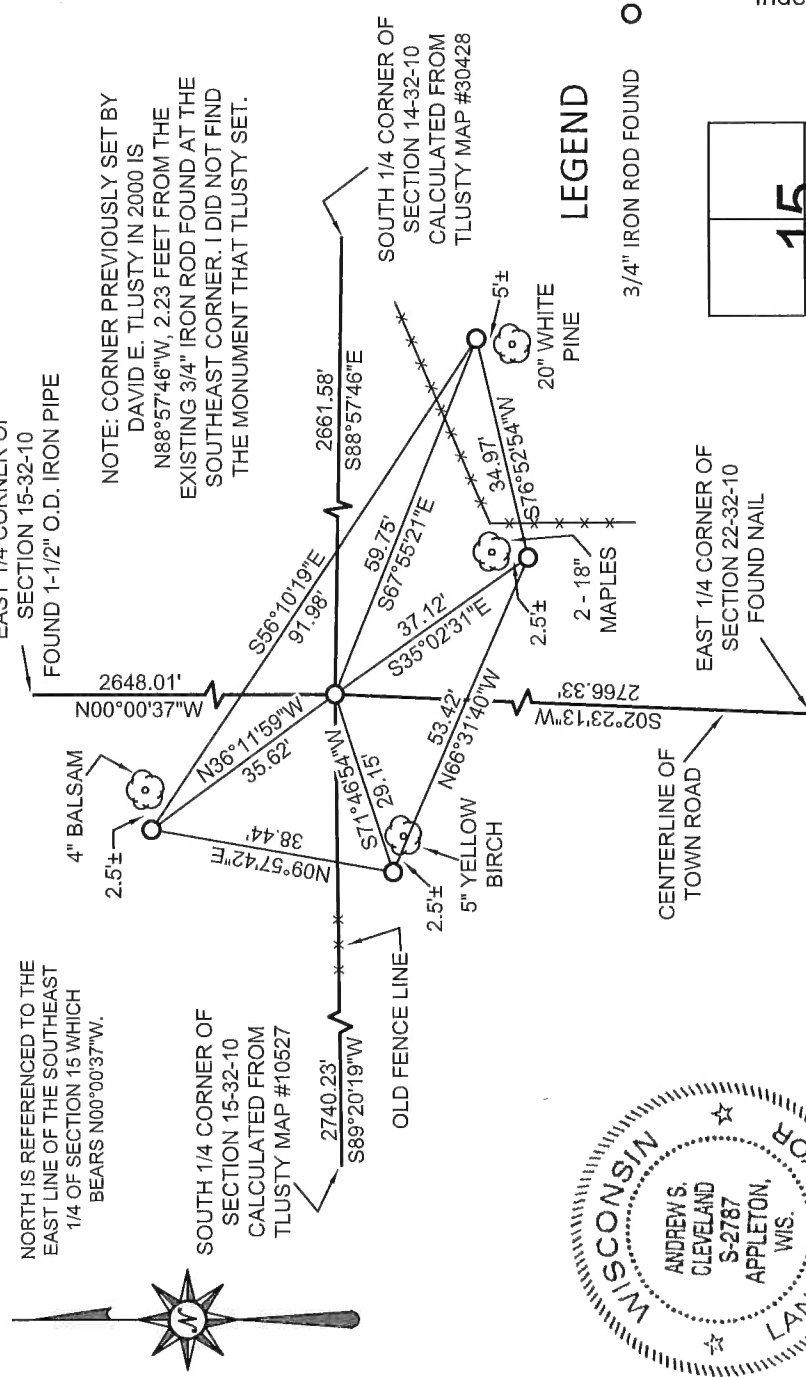
In 2024 Kevin M Whipple, PLS 2444 performed a survey (Job Number 540122) in where he set a 3/4" iron rod at the intersection of the centerline of the road with an old fence west of the road. I found this corner and along with the testimony of the Plsaks I have accepted the corner as set by Kevin M Whipple. PLS 2444 as the true corner.

Found a 3/4" iron rod and tied off as shown.

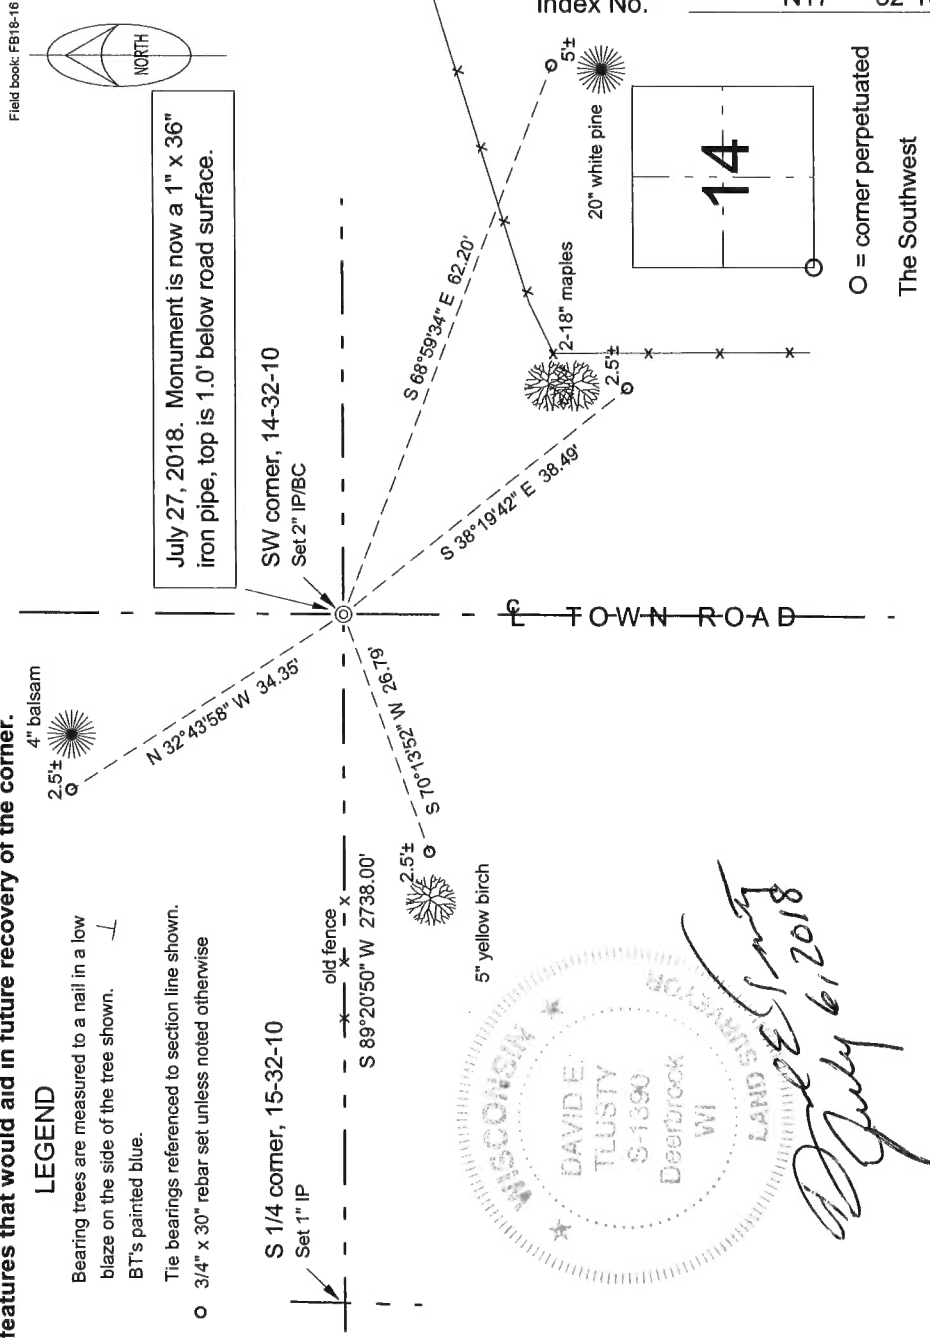
July 27, 2018. D. Tlusty, at the request of Tim Plzak, set a 1" x 36" iron pipe for the corner. Mike Plzak found the brass cap from the previous monument which apparently has frost heaved out of the ground. I used the rebar SW at 26.79' and the rebar SE at 38.49' to reset the corner, then check distance to traverse point to the south, within 0.03 feet. At 26.9± east of the corner, I found a piece of RR rail set on end.

Set a 2" x 30" galvanized, flanged bottom iron pipe monument, 0.7' below road surface at gate.
