LANGLADE COUNTY  
U.S. PUBLIC LAND CORNER RESTORATION

The East Quarter corner of Section 15, T. 32 N., R. 10 E., Langlade County, WI.

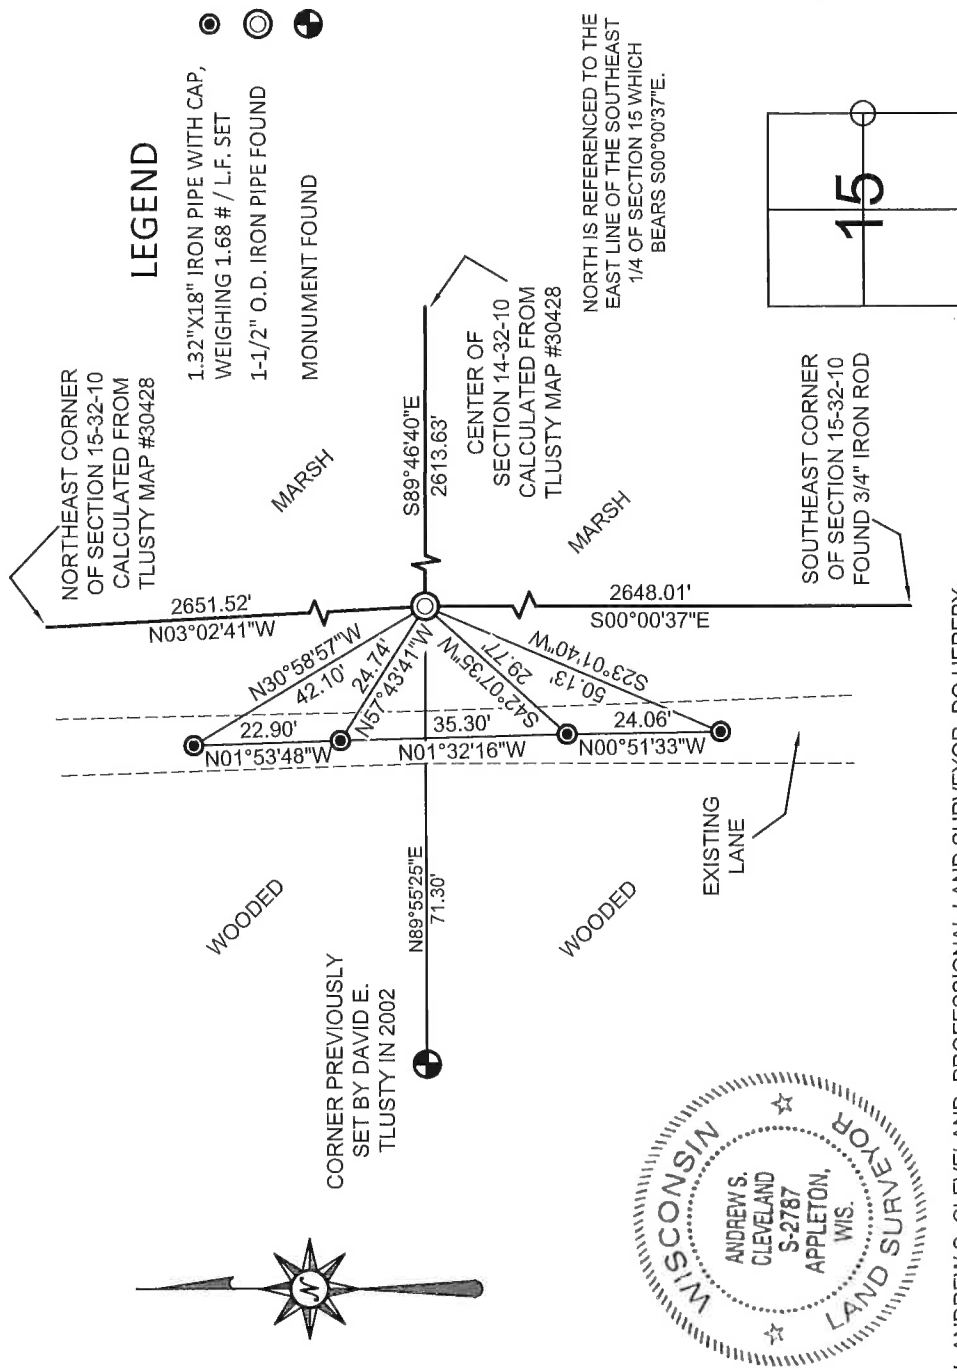
In 2024 Kevin M Whipple, PLS 2444 performed a survey (Job Number 540122) in where he set a 1-1/2" X 42" O.D. iron pipe at the location the Plzaks remembered the previous monument to be prior to the removal of the beaver dam. I found this corner and along with the testimony of the Plzaks I have accepted the corner as set by Kevin M Whipple, PLS 2444 as the true corner.

Found a 1-1/2" O.D. iron pipe and tied off as shown.

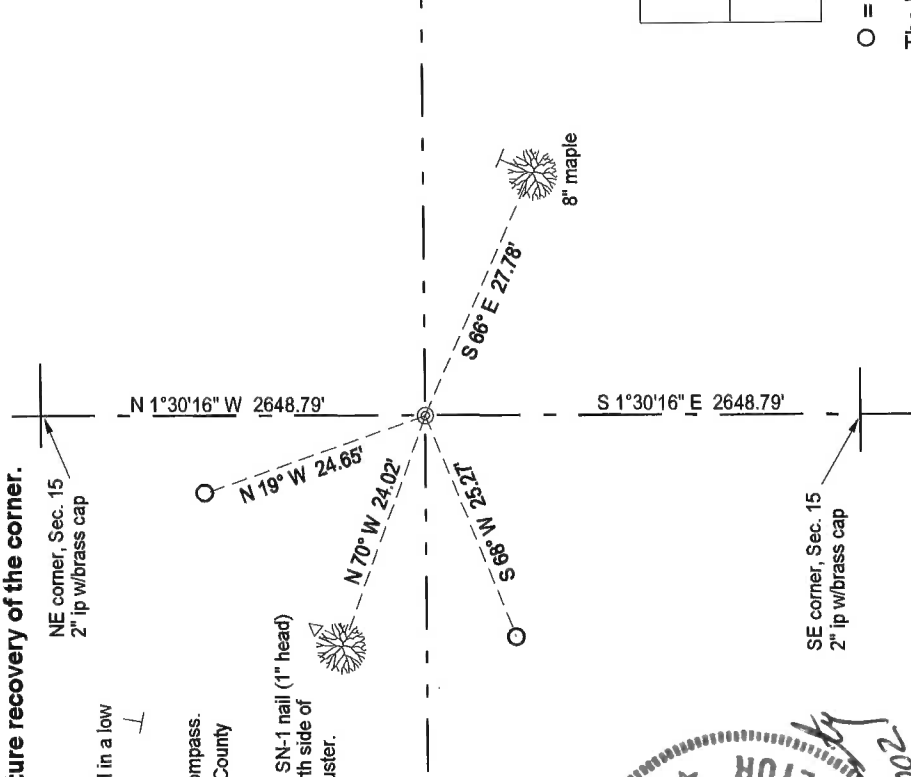
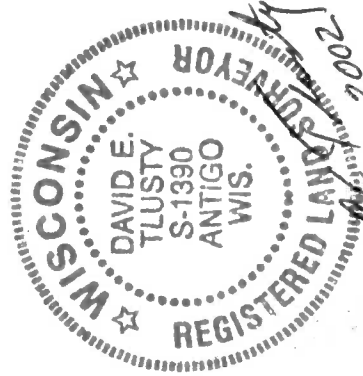
○ = corner perpetuated  
The East Quarter  
corner of Section 15,  
T. 32 N., R. 10 E.,  
Langlade County, WI

The original corner was established in 1860 by Hiram Fellows. Original bearing trees: hemlock, 14", N57°E, 7 links and a hemlock, 24", S76°W, 12 links. Original corner was 121' north of creek flowing SW. Brooks, in 1908, found "Orig. BT stump Hemlock, NE badly rotten. Other Pine instead of Hemlock". He used the corner for survey work in Section 14. I found no evidence of the original or Brooks' corner so I re-established the corner by single proportionate measurement between adjoining section corners. The corner falls 90' north of an old creek channel and 130' north of the current channel, and approx. 35' West of a north-south logging road.

Set a 2" x 30" galvanized, flanged bottom iron pipe monument, up 0.2', with 3 1/4" brass cap stamped to identify the corner. Set a white vinyl sign post 0.5' west of the corner monument.

Set Bernsten SN-1 nail (1" head) upright in north side of 30" maple cluster.
