## RESTORATION OF LOST ORIGINAL GOVERNMENT SURVEY CORNER

Southeast section corner of section 24, T35N-R13E, 4th P. M. - continued.

## U.S. PUBLIC LAND SURVEY MONUMENT RECORD

Corner to Section 9, 30, 24, 30 35N, R 14 E Section (Section/Quarter)

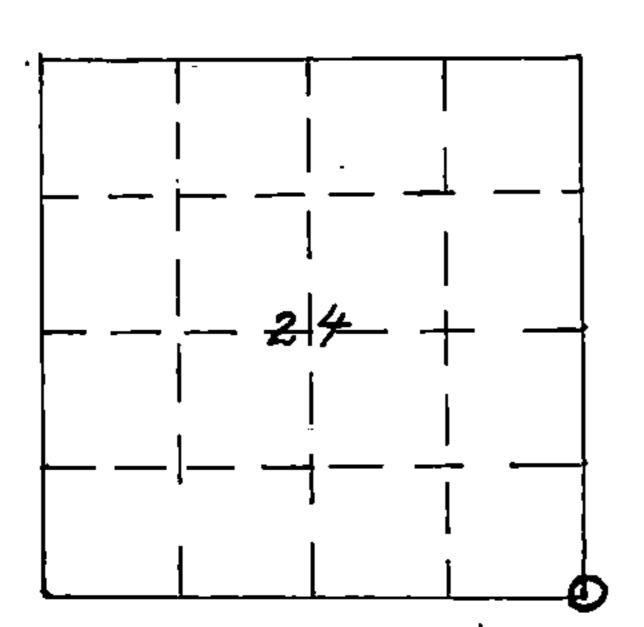
O = Corner monument restored.

Description as to how corner was located:

At the approximate location of the corner was located a post about 30 years old. It is very possible that two stumps located the correct distances from the post are the remnants of the original bearing trees described in the original field notes as "Y. Birch 16 N80W 13 links, and, Hemlock 15 S78W 50 links". The corners of 13, 24, 18, 19, and 25, 36, 30, 31, have been previously established with a distance between them of 162.67 chains. The post described is only 20 links east of a straight line between the existing corners. By pro-ration, the corner should be  $81.33\frac{1}{2}$  chains south of 13, 24, 18, 19. The post is actually 79.93 chains south. However, at the site of the  $\frac{1}{4}$  cr. between 25 and 30 is a lake known as "Ed's. Lake". At this point is such a discrepancy between the original field notes and actual measurements, that it is impossible to compare actual with record distances. Thus, I feel that the  $1.40\frac{1}{2}$  chains per mile of

line that proportionate measurement would pro-rate between the established corners is entirely absorbed in the original erroneous recording of the width of the lake. Therefore, I believe that the position of the post, just 79.93 chains south of the corner of 13, 24, 18, 19, is a true reflection of the original position of 24, 25, 19, 30. I replaced the post with the above noted pipe.

At the point determined for the location of the corner I emplaced as

"GALVANIZED IRON PIPE, THREE FEET LONG, WITH AN ALUMINUM CAP DENOTED AS, 'KIMBERLY-CLARK CORP T35N 19, 24, 25, 30, R13-14E SPERHAKE RLS 463 10-12-62'. THE PIPE IS ONE INCH IN DIAMETER".

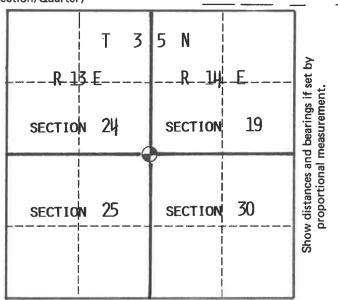
O = Corner monument restored.

In 1962 Neal Sperhake, RLS found a wood post and possible bearing tree stumps and monumented the corner using a 1" iron pipe with aluminum cap stamped for corner.

Found Sperhake's corner in good condition and restored the corner to USFS standards.
