U.S.	PUBLIC	LAND	SURVEY	MONUMENT	RECORD
•••				1110110111

State of Wisconsin				
1				
State of Wisconsin State				
I Gary L.Pisoni , do hereby certify that on the 22nd day of December , 19 93, I found evidence of the Northeast Section corner of Section 13  Township 36 , North, Range 14 East , Fourth Principal Meridian, as described hereon; and that from this evidence I established a new monument and accessories as described hereon to perpetuate the original location of this corner.				
Resident witnesses:				
•				
**** **********************************				
·				
······································				
SECTION 13

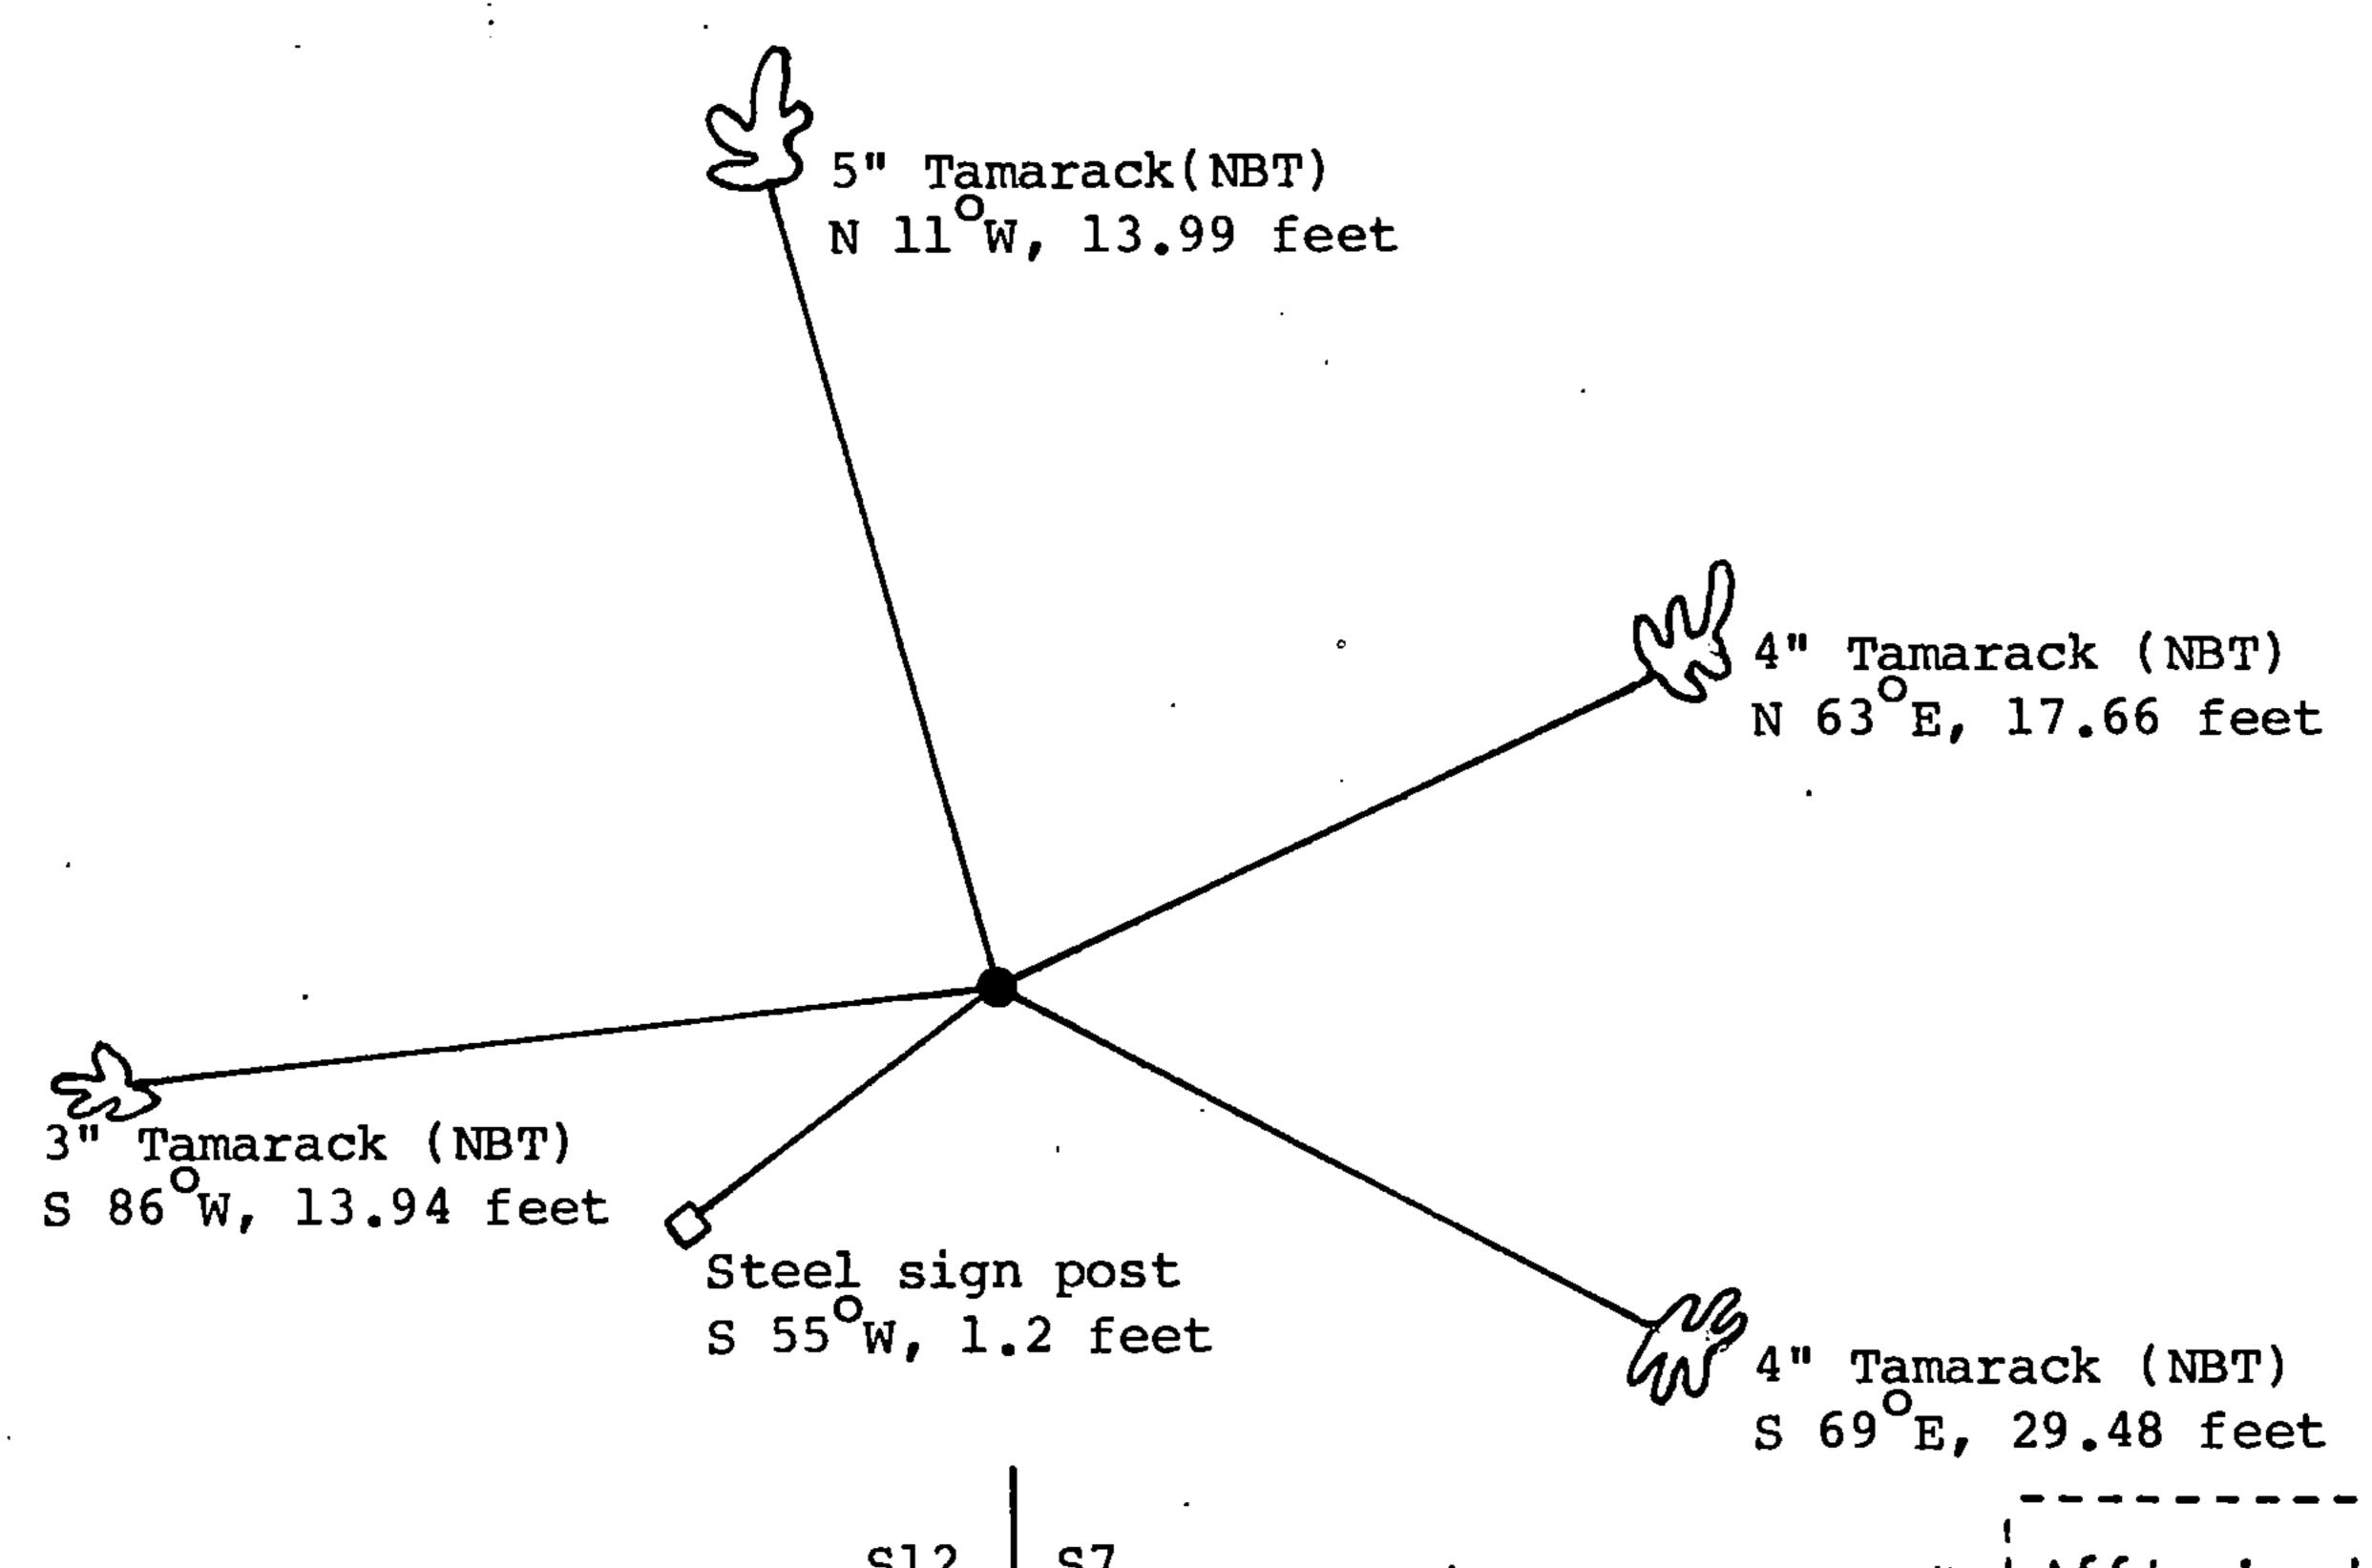
S12 Section Corner **S13 S18**

On 12/22/93, I found the above described monument but all bearing tree references were missing.

Describe any material discrepancy between the location of the corner as restored or reestablished and the location of that corner as previously restored or reestablished by distance and direction. Show the discrepancy on the plan view drawing under (d), above. Show the distances between the corner as previously restored or reestablished and (1) the corner as restored or reestablished, and (2) to at least 2 of the witness monuments shown on the drawing in (d), above.

See drawing below

Restored through acceptance of a found perpetuated location.

Blazed and scribed the following new corner references: (Measurements taken to

Tamarack 4"
N 63°E
17.66 feet

Tamarack 4"
S 69°E
29.48 feet

Tamarack 3"
S 86°W
13.94 feet

Tamarack 5" N 11 W 13.99 feet Steel sign post S 55 W 1.2 feet
