U. S. PUBLIC LAND SURVEY MONUMENT RECORD.

Section corner to Sections 8, 9, 16, and 17, T.32N., R.14E., Langlade County, Wisconsin.

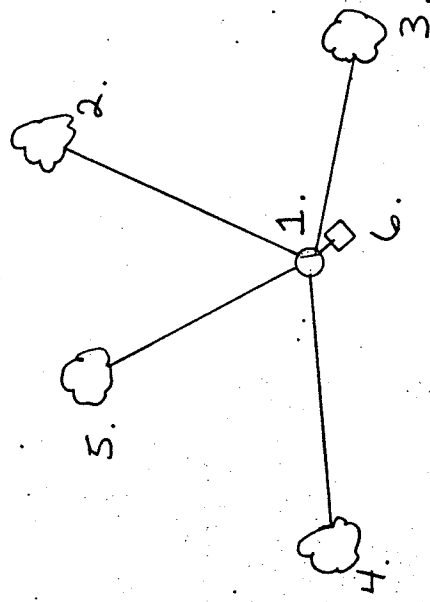
In 1989, Alan Harrison, (RLS) found corner in good condition, put nails in existing B.T.'s, added on e B.T. and a sign post.

1. 1½" iron pipe with 4" brass cap.
2. Sugar, 9", N.32°E., 45.75 feet.
3. Sugar, 10", S.72°E., 18.88 feet.
4. Sugar, 9", S.80°W., 35.29 feet.
5. Sugar, 10", N.21°W., 33.37 feet.
6. Steel sign post, Southeast, 1.30 feet.
