U. S. PUBLIC LAND SURVEY MONUMENT RECORD

Section corner to Sections 10, 11, 14, and 15, T.34N., R.16E.

Section Corner to Sections 10, 11, 14 & 15; T.34N., R.16E., 4th P.M.

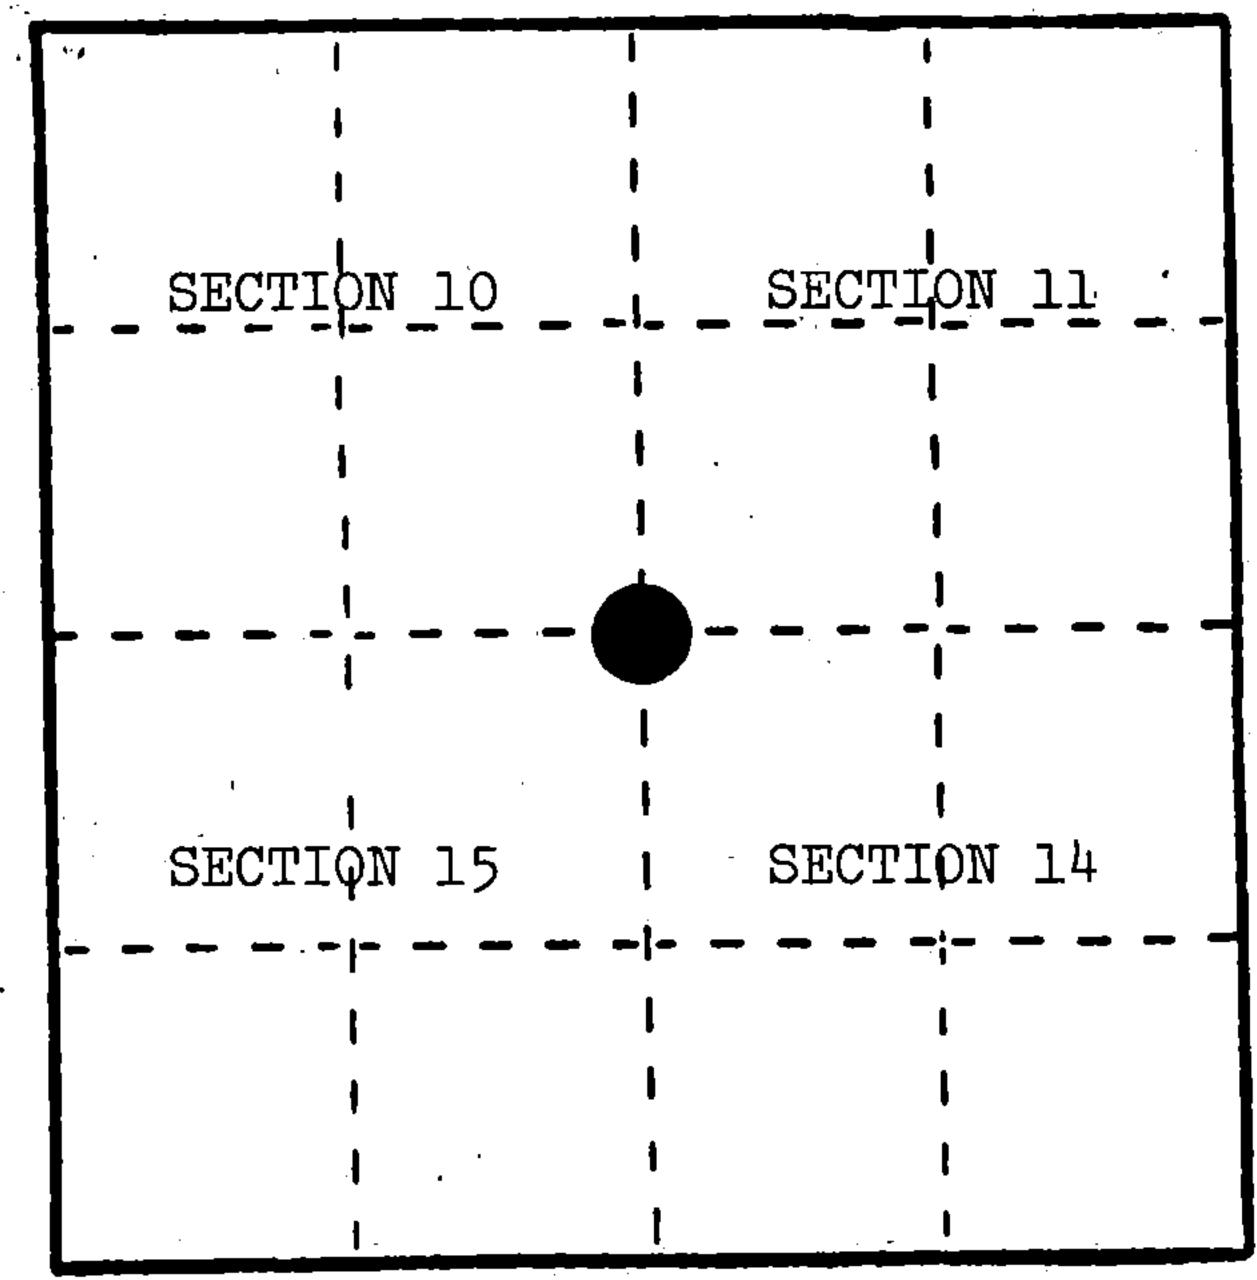
In 1858, James McBride set wood post with the following BTs: Tamarack, 14", N.20°W., 57 links; Tamarack, 12", N.29°E., 20 links; Black Ash, 12", S.44°E., 30 links; Birch, 16", S.11°W., 17 links.

January 11, 1935, C. J. Priegal--Truck Trail #344 found a fence line and Forest Service poster.

January, 1984, Milo Stefan, Bay Shore Farm Road runs north and south from section corner. Found no evidence of fence line or corner position.
