LANGLADE COUNTY U.S. PUBLIC LAND CORNER RESTORATION

The quarter corner common to Sections 19 & 20, T. 33 N., R. 13 E., Langlade County, WI.

PLSS field condition report

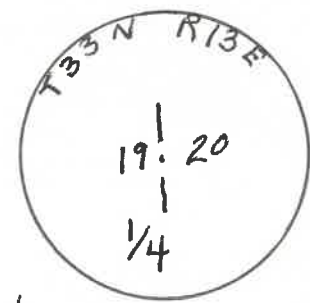
Description of corner evidence found:
1" Axle for corner
4"x4" scribed cedar post 10" south of axle
old B.T.
Pine stump 558W 11'3"

Description of monument and accessories I established to perpetuate the original location of this corner.
Set 2" IRON PIPE WITH BRASS CAP IN PLACE OF AXLE
New B.T.'s
White pine 22" S75E 4'3"
Hemlock 14" S41W 47'6"
Hemlock 14" S45W 45'9"
