U. S. PUBLIC LAND SURVEY MONUMENT RECORD

Quarter Corner Common to Sections 3 and 9, T36N-R16E

Index Number E-15 (T36N-R16E)

Forest County, Wisconsin

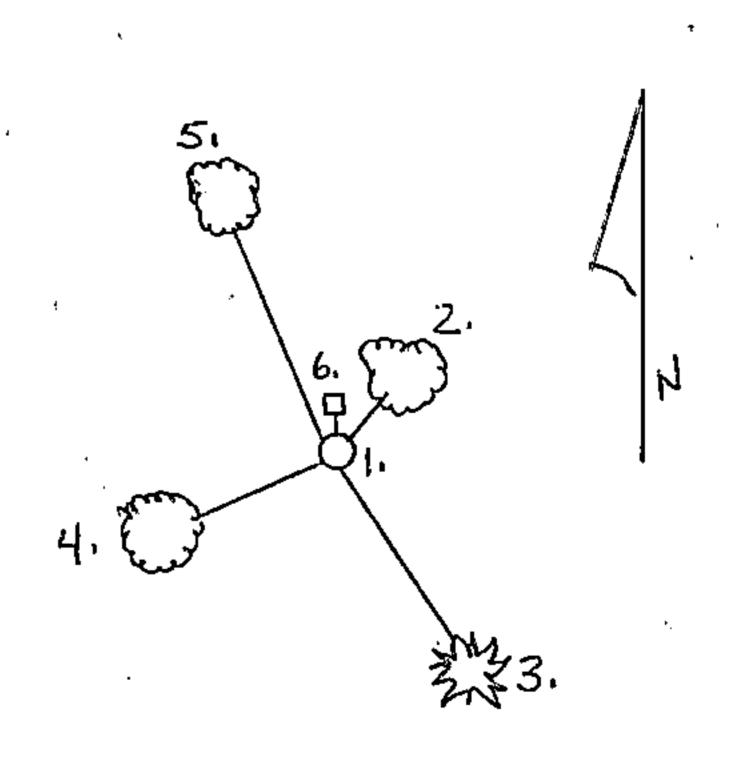
- In the plan view drawing below, provide reference tles to at least 4 witness monuments, or, If the location is within a municipality, to at least 2 witness monuments. (witness monuments shall be made of concrete, natural stone, Iron prother equally durable material.)

- 1. 2½" x 36" Aluminum monument with location stamped on cap.
- 2. Y. Birch 20" N38°E 6.58' feet.
- 3. Cedar 10" S31°E 53.56 feet.
- 4. Y. Birch 12" S57°W 22.22 feet.

- 5. Y. Birch 14" N34°W 48.61 feet.
- 6. Steel sign post North 1.60 feet.
