# U. S. PUBLIC LAND SURVEY MONUMENT RECORD

Section corner to Sections 22, 23, 26, and 27,  
 T.38N., R.13E.

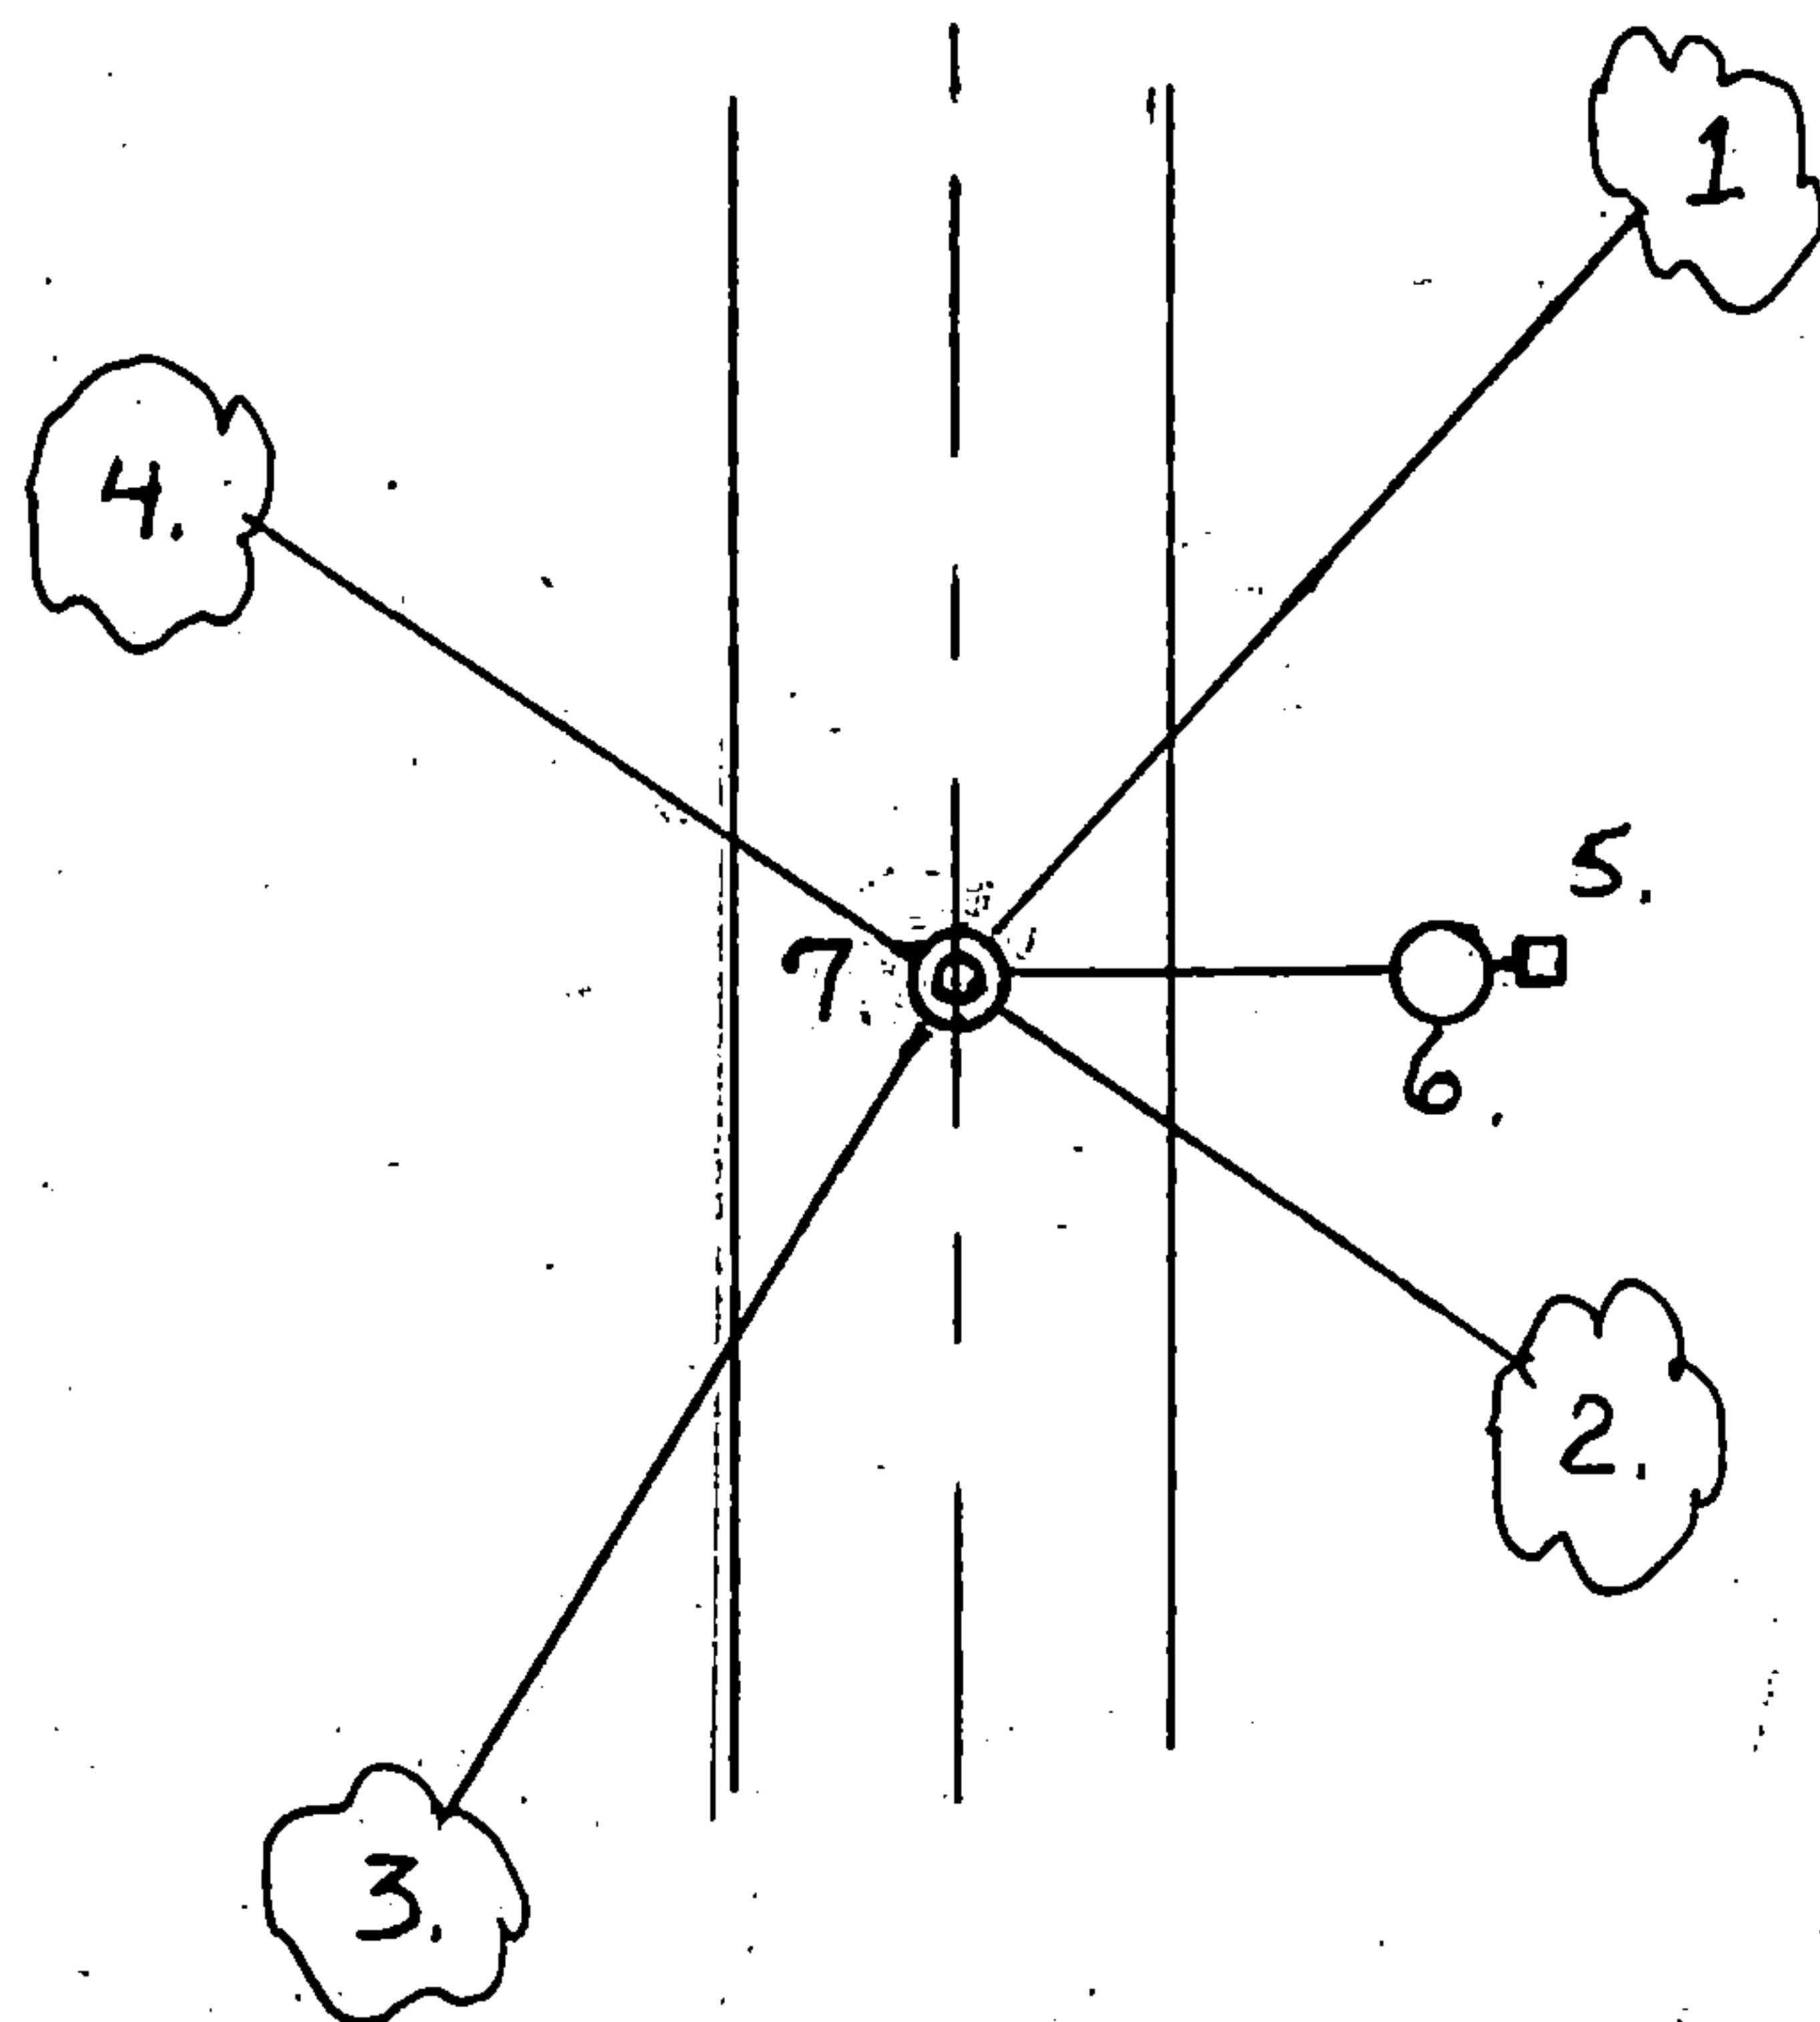
- (d) Show a plan view drawing depicting the relevant monuments and reference ties which is sufficient in detail to enable accurate relocation of the corner monument if the corner monument is disturbed. Indicate north.

1. Black Ash, 5", N.40°E., 76.29'
2. Hemlock, 12", S.65°E., 57.00'
3. Cedar, 5", S.34°W., 79.82'
4. Cedar, 7", N.65°W., 77.59'
5. Steel Sign Post, East, 24.75'
6. 2" x 60" aluminum reference monument, East, 23.72'
7. Railroad spike marking corner location.

May 30, 1984, Milo Stefan found location poster on east side of highway. Excavated highway to below marsh along centerline. Found no trace of post. Accepted location poster and centerline of highway as the best evidence of corner position. Corner position marked by a railroad spike in centerline of Highway 55.
