LANGLADE COUNTY U.S. PUBLIC LAND CORNER RESTORATION

The Southeast corner of Section 24, T. 31 N., R. 09 E., Langlade County, WI.

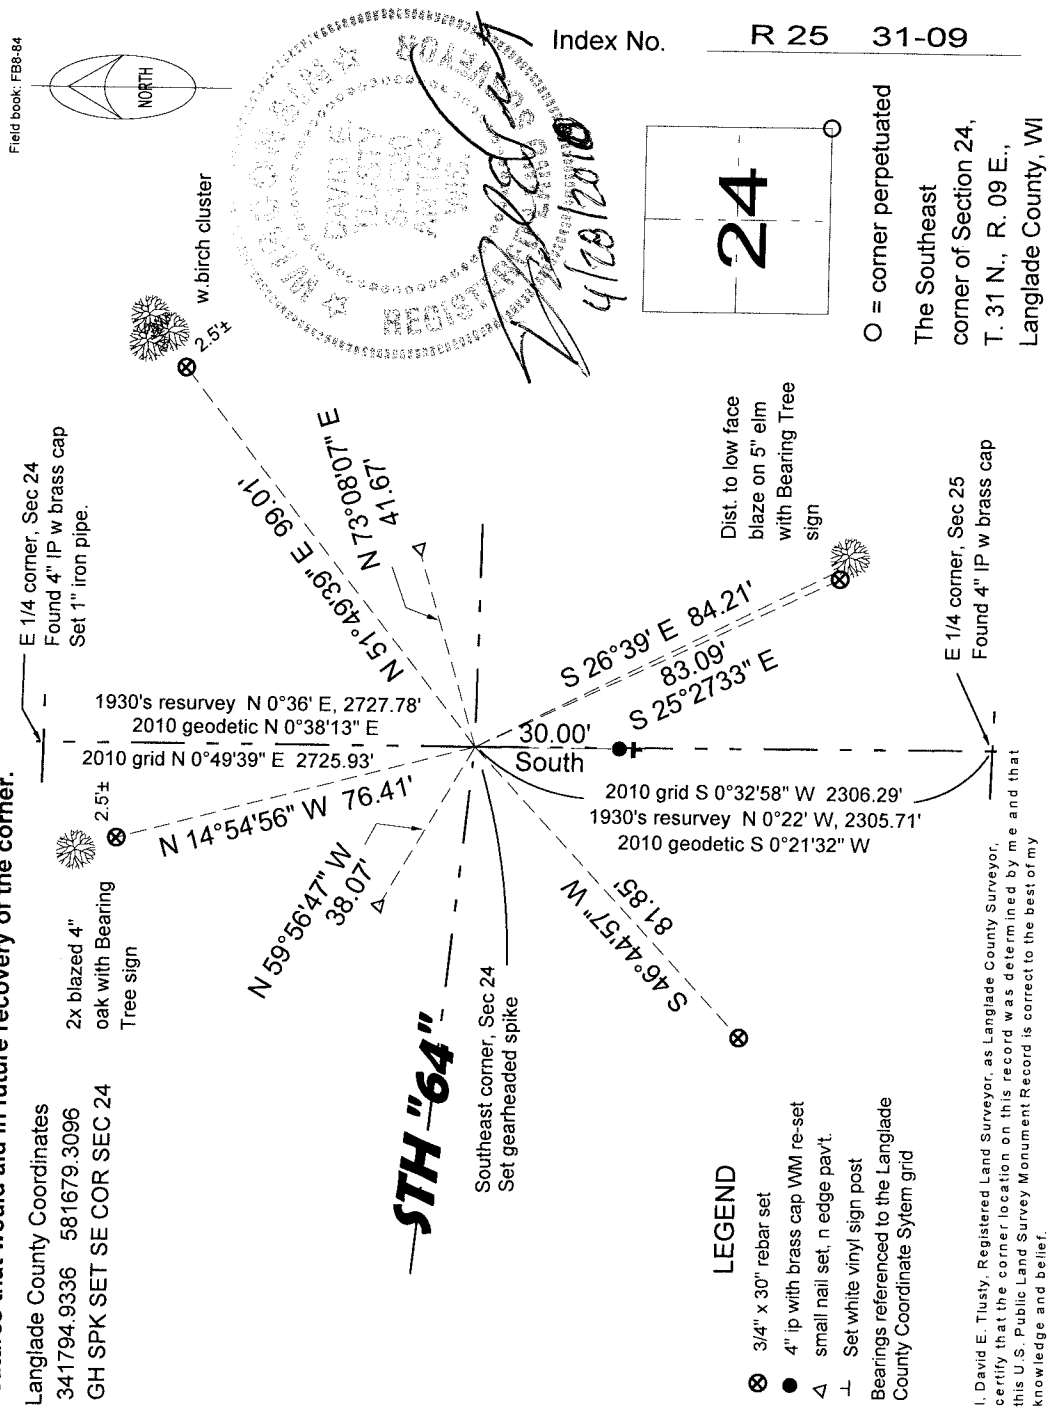
Describe the accessories used to perpetuate the corner. Include a plan view drawing and accessories found/set. Describe measuring point on bearing trees. Show any topographic features that would aid in future recovery of the corner.

Langlade County Coordinates
341794.9336 581679.3096
GH SPK SET SE COR SEC 24
