U. S. PUBLIC LAND SURVEY MONUMENT RECORD

Quarter corner to Sections 5 and 8, T.31N., R.15E.

T 31 N. R 15 E

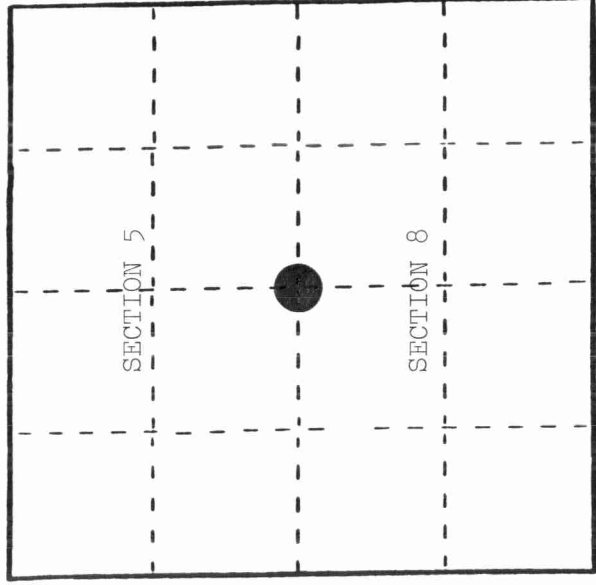
O = Corner monument restored.

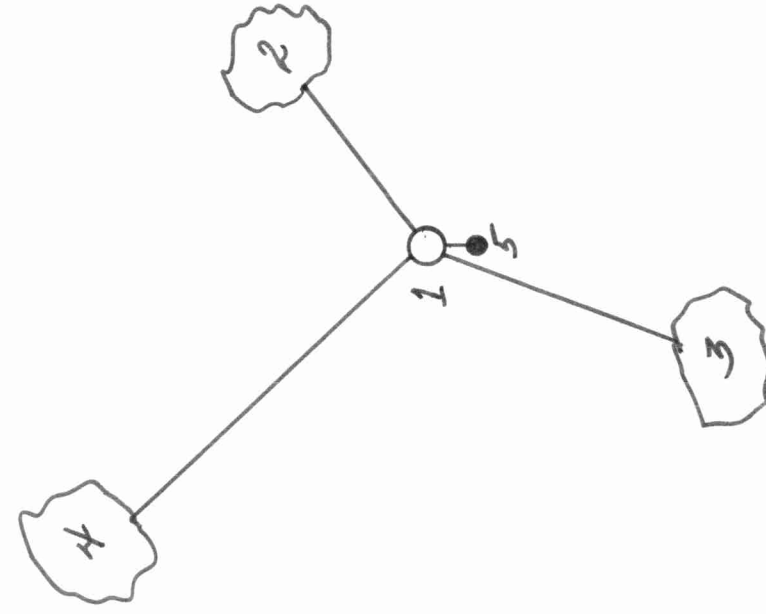
- (d) Show a plan view drawing depicting the relevant monuments and reference ties which is sufficient in detail to enable accurate relocation of the corner monument if the corner monument is disturbed. Indicate north.

1. 2" x 60" aluminum monument stamped to identify the corner.
2. Cedar, 7", N.57°E., 12.02 feet
3. Black Spruce, 10", S.17°W., 18.90 feet
4. Cedar, 6", N.41°W., 27.02 feet
5. Steel Sign Post, 8', South, 1.7 feet
6. Iron Pipe, 1 1/4", S.02°W., 139.20 feet

Iron pipe, believed to have been placed by landowner, 139.20 feet out of position.

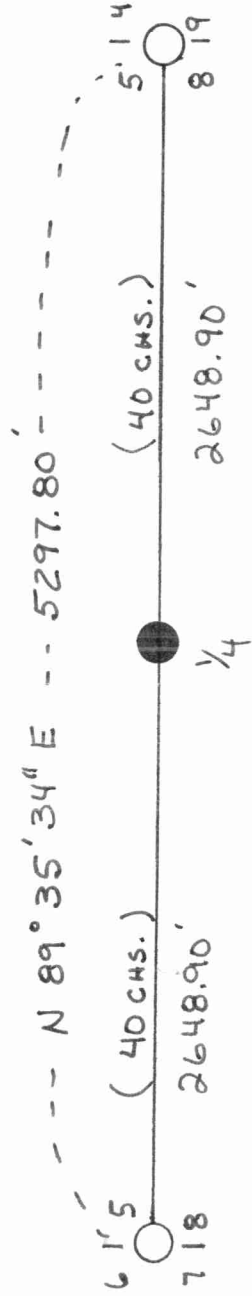
(g&h) Was the corner reestablished through lost corner proportionate methods? If so, show the method, including the directions and distances to other public land survey corners used as evidence or used for proportioning in determining the corner location?

Yes. Single proportionate.
