U. S. PUBLIC LAND SURVEY MONUMENT RECORD

Qarter corner common to sections 29 and 30, T.36N., R.16E. Forest County, WIsconsin.

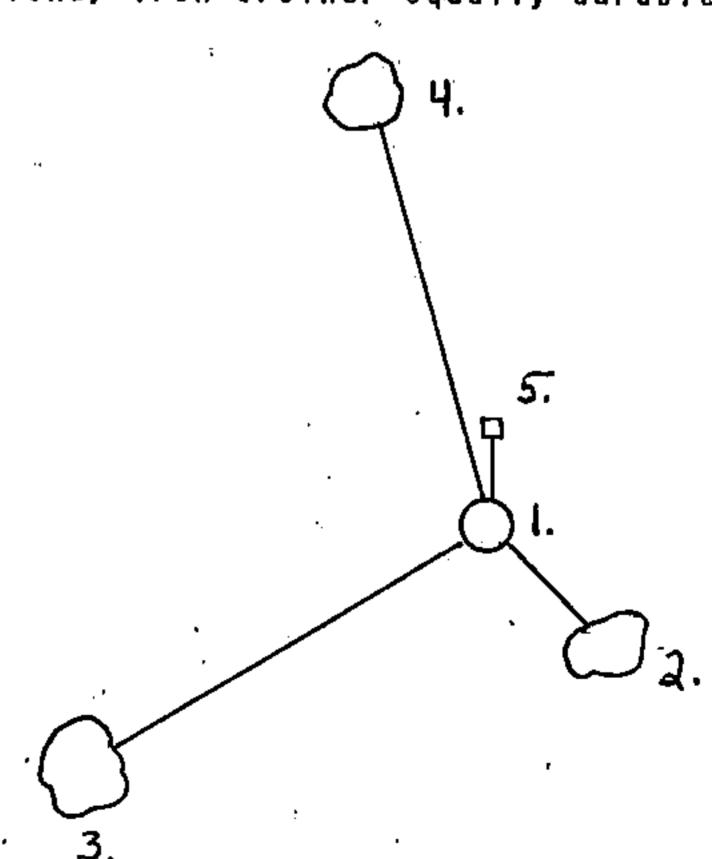
- (c) In the plan view drawing below, provide reference ties to at least 4 witness monuments, or, if the location is within a municipality, to at least 2 witness monuments. (witness monuments shall be made of concrete, natural stone, from orother equally durable material.)
- (d) Show a plan view drawing depicting the relevent monuments and reference ties which is sufficient in detail to enable accurate relocation of the corner monument if the corner monument is disturbed. Indicate north.
 - 1. 2½"x36" Aluminum monument with tablet stamped to identify the corner.
 - 2. Balsam, 11", S.44°E., 3.74 feet.
 - 3. Sugar, 4", S.50°W., 25.92 feet.
 - 4. Cherry, 7", N.14°W., 27.27 feet.
 - 5. Steel Sign Post, North, 1.13 feet.

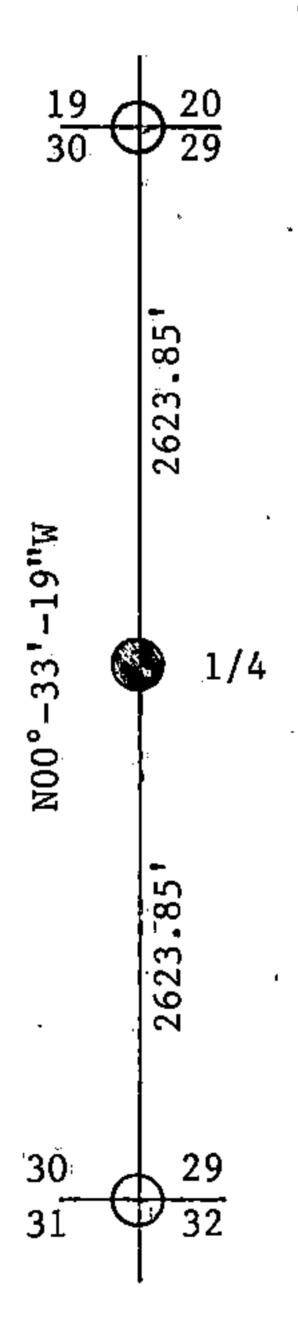
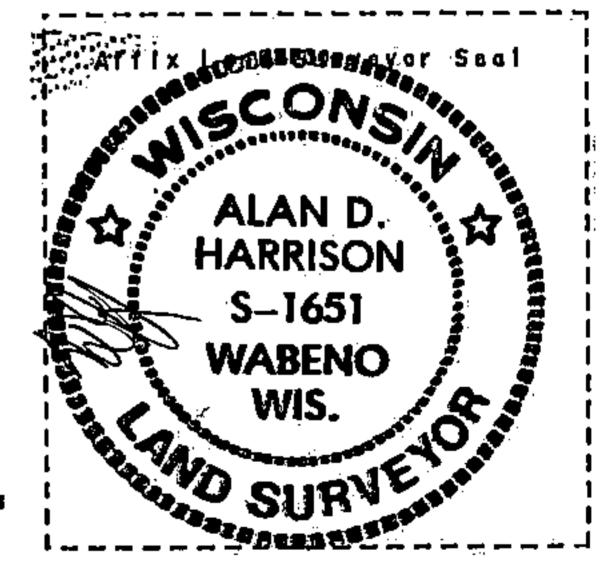
(g.B.h) Was the corner reestablished through lost corner proportionate methods? It so, show the method, including the directions and distances to other public land survey corners used as evidence or used for proportioning in determining the corner location?

Yes
