# U.S. PUBLIC LAND SURVEY MONUMENT RECORD - LANGLADE COUNTY

Wisconsin Corner ID: 43311012000

Location: East Quarter Corner

Section 1, Township 33 North, Range 11 East,

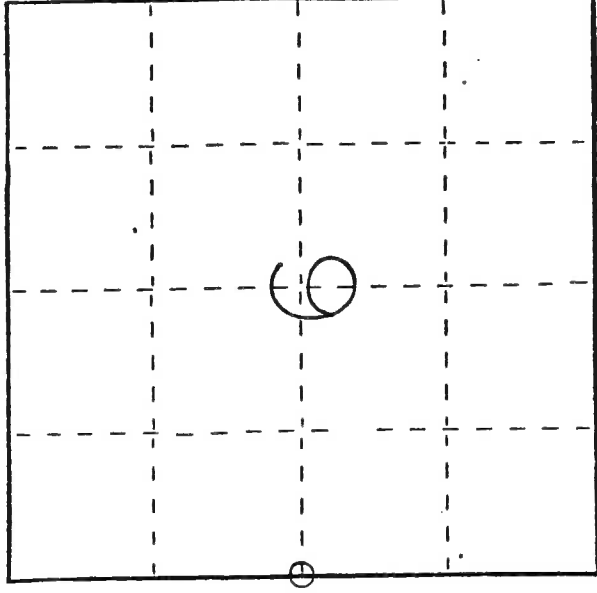
West  $\frac{1}{4}$  Corner, Section 6, T33N, R12E, Town of Ainsworth, Langlade County, Wisconsin.

Found an existing 3 inch iron pipe monument with cap, set in 1936 by the U.S. Forest Service, 33 feet north of section corner.

Corner restored as previously restored.

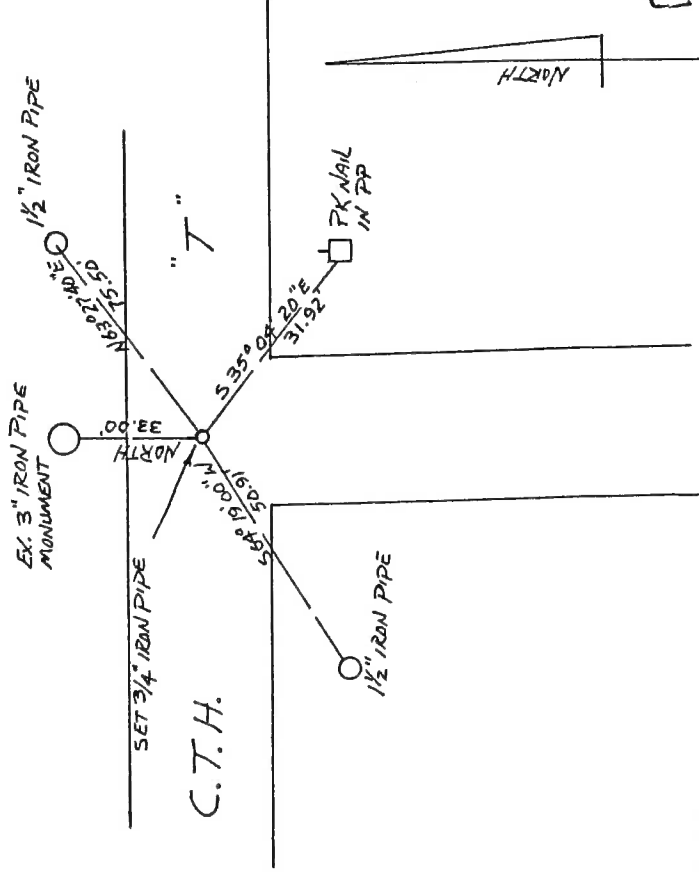
C-25

- (d) Show a plan view drawing depicting the relevant monuments and reference ties which is sufficient in detail to enable accurate relocation of the corner monument if the corner monument is disturbed. Indicate north.
