U. S. PUBLIC LAND SURVEY MONUMENT RECORD

Quarter Corner to Sections 26 and 27, T.34N. R.14E., Forest County, Wisconsin

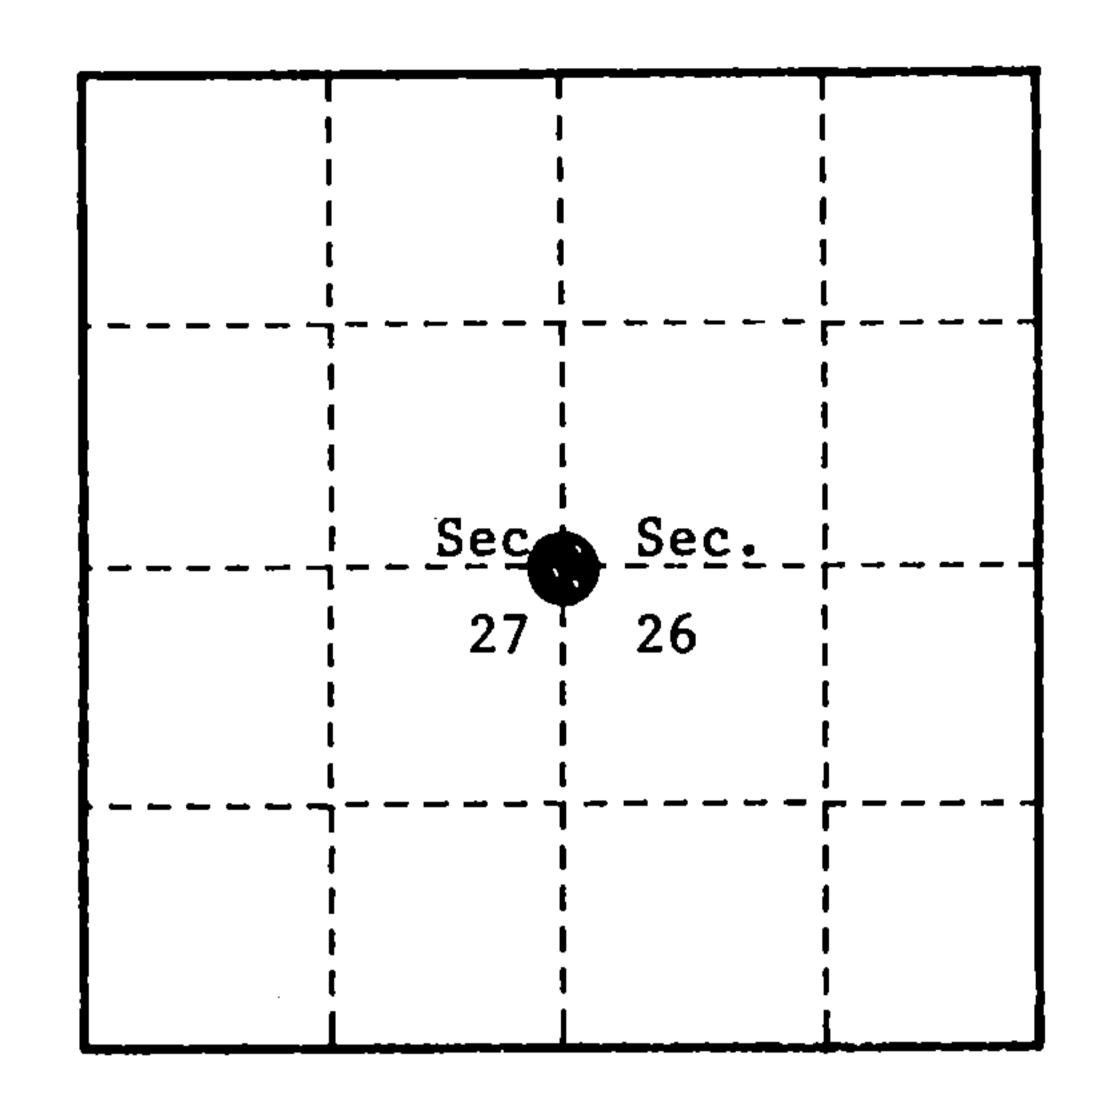
. O - Corner monument restored.

State Plane Coordinates
Wisconsin North Zone
87929.74763-N
2297649.63316-E

Geographic Coordinates 45-24-01.88040-N 088-43-07.05351-W

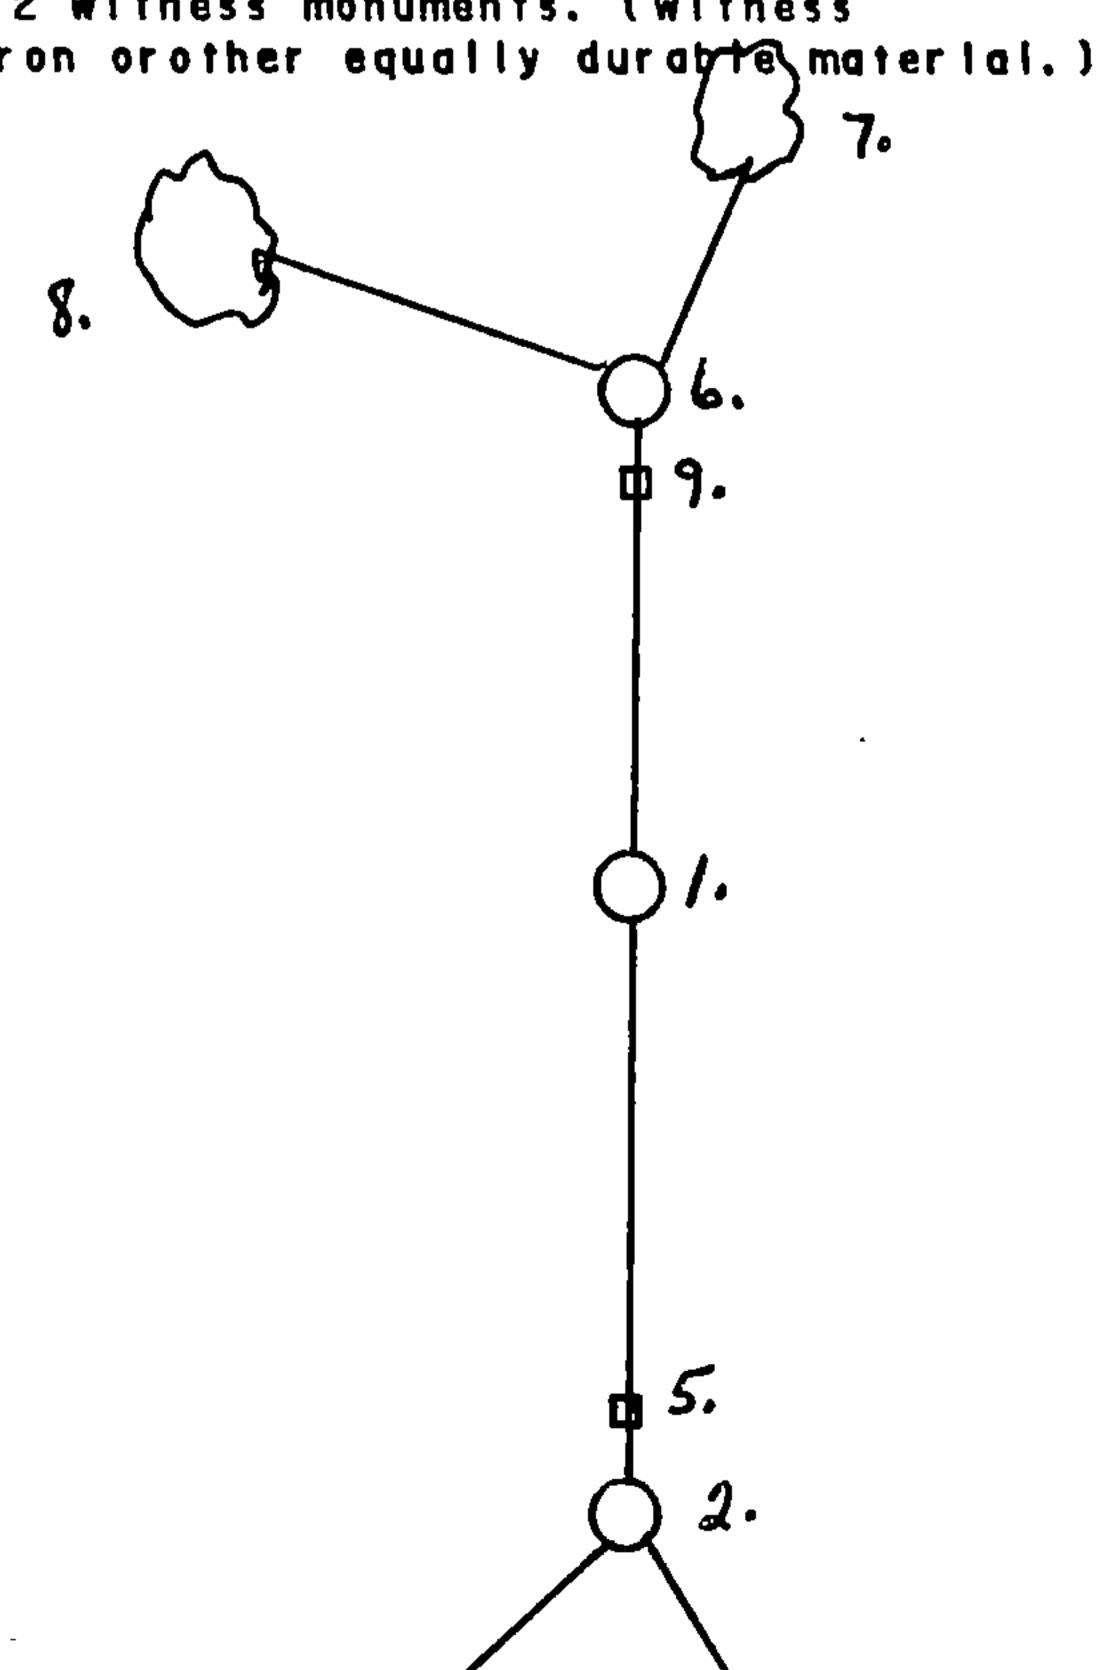
- 1. True corner position not monumented.
- 2. 2½" x 36" Aluminum Monument for Witness Corner, S.00°-55'-20"W., 658.81 ft.
- 3. Spruce, 12", S.30°E., 52.92 ft.
- 4. Aspen, 7", S.46°W., 37.04 feet
- 5. Steel Sign Post, North, 0.97 ft.
- 6. 2½" x 60" Aluminum Monument for Witness Corner, N.00°-55'-20"E., 212.58 ft.
- 7. Spruce, 6", N.29°E., 78.36 ft.
- 8. Aspen, 6", N.65°W., 69.14 ft.
- 9. Steel Sign Post, South, 1.26 ft.

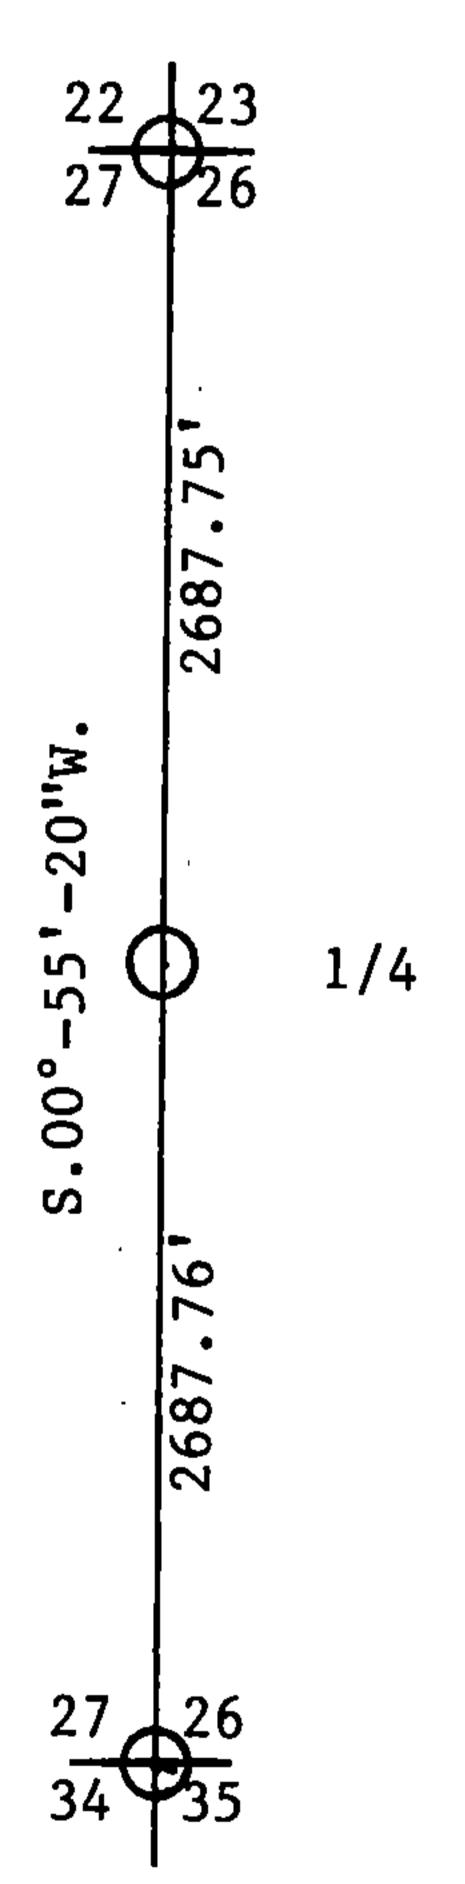
(g & h). Was the corner reestablished through lost corner proportionate methods? If so, show the method, including the directions and distances to other public land survey corners used as evidence or used for proportioning in determining the corner location?

Yes
