## U. S. PUBLIC LAND SURVEY MONUMENT RECORD

Quarter corner to Sections 9 and 16, T.34N., R.16E.

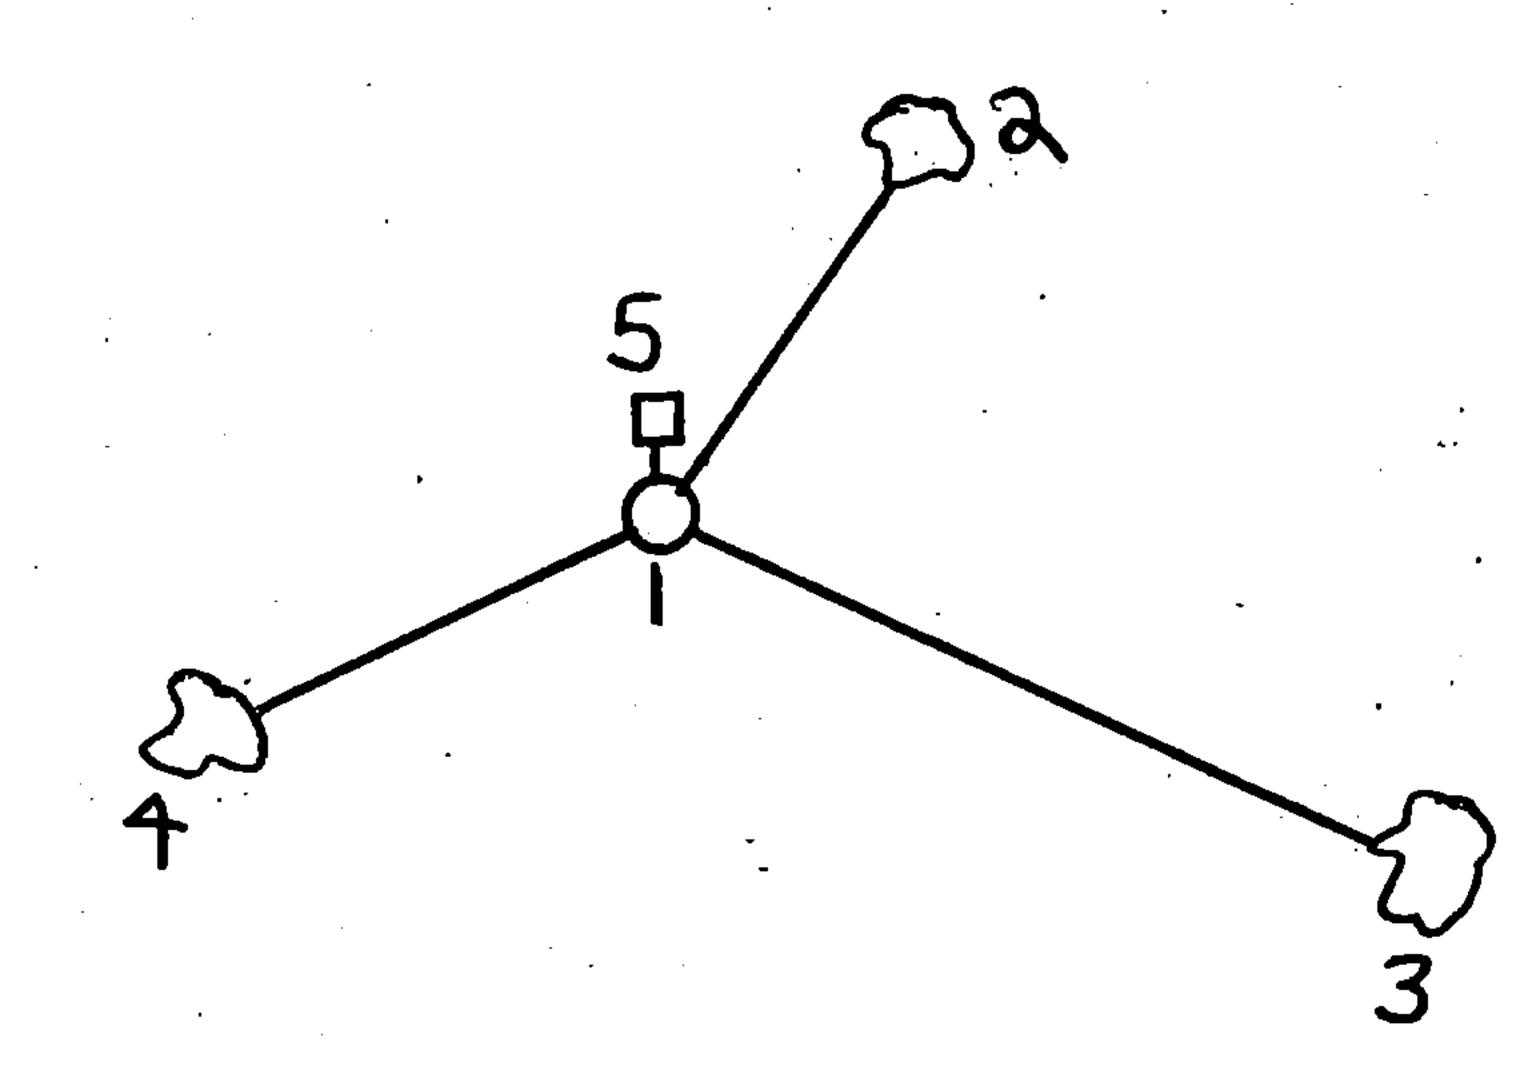
Describe witness monuments.
- (d) Show a plan view drawing depicting the relevant monuments and reference ties which is sufficient in detail to enable accurate relocation of the corner monument if the corner monument is disturbed. Indicate north.
- 1. 2" x 36" aluminum monument stamped to identify the corner.

2. Aspen, 7", N.33°E., 23.61'

- 3. Triple Basswood, 11", S.73°E., 94.00'
- 4. Black Cherry, 4", S.62°W., 33.73'
- 5. Steel Sign Post, North, 1.5'
