U. S. PUBLIC LAND SURVEY MONUMENT RECORD

Section corner to 3, 4, 33, and 34, T.34-35N.R.16E.

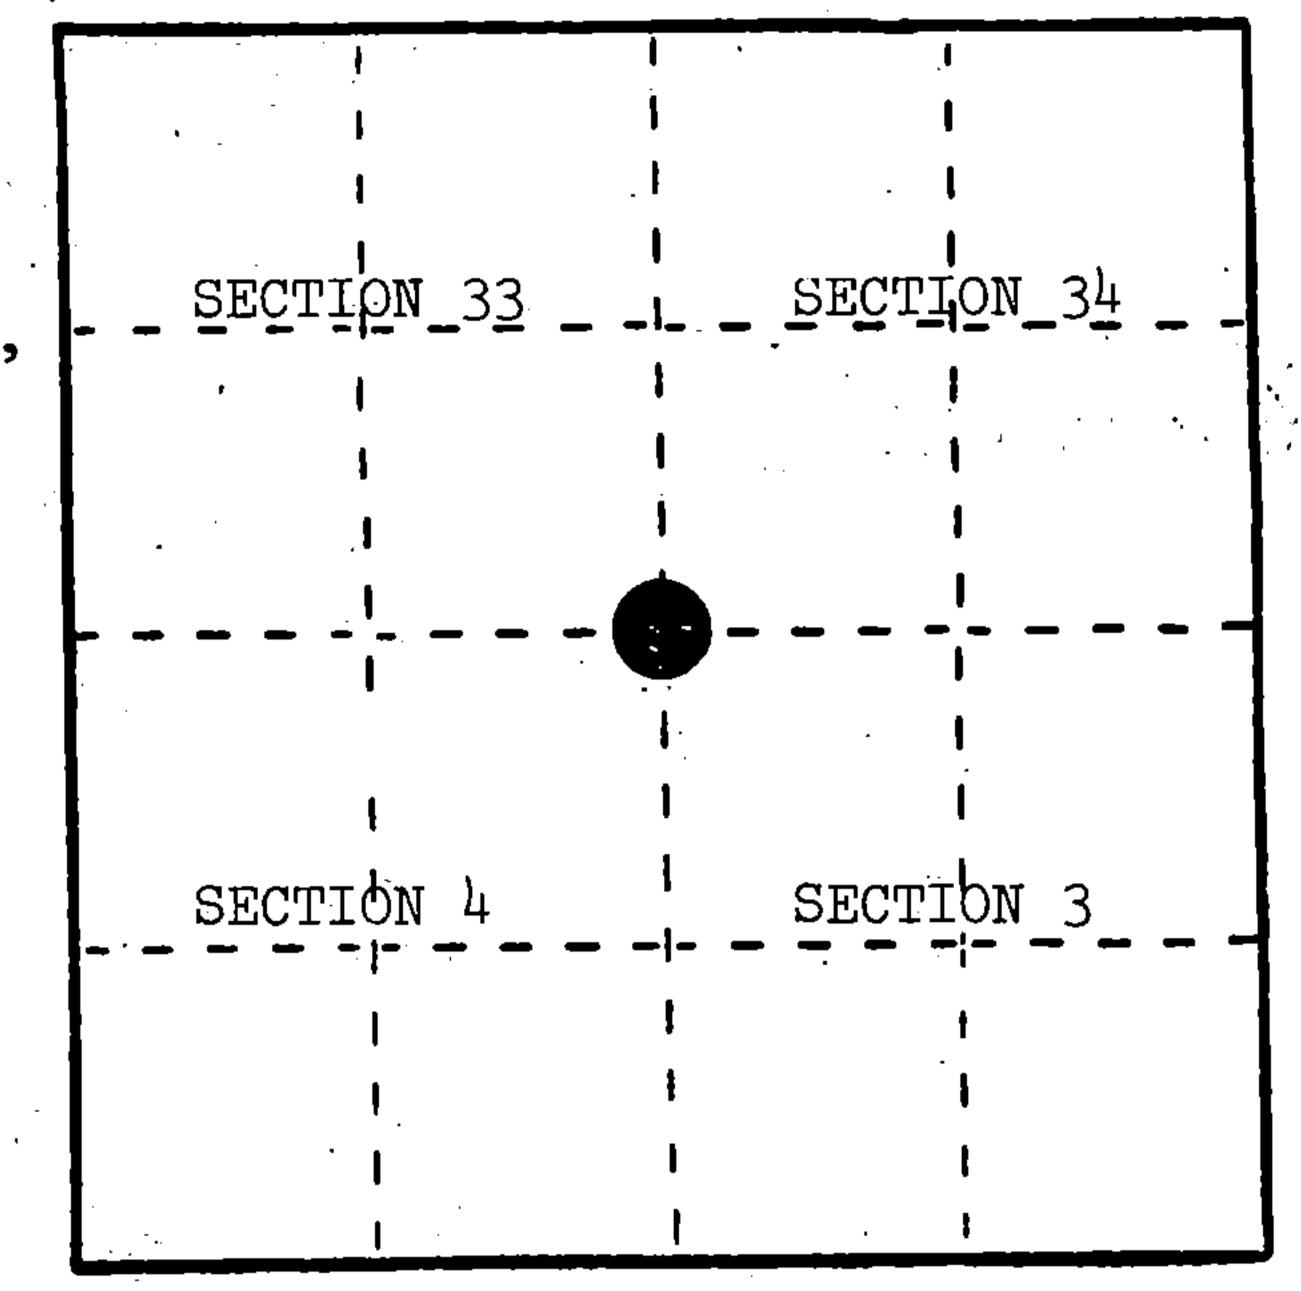
- Corner monument restored.

In 1857, Artemas Curtis set post with the following BTs: Hemlock, 12", N.50°W., 11 links; Hemlock, 12", N.16°E., 26 links; Cedar, 12", S.40°E., 4 links; Hemlock, 10", S.43°W., 33 links.

December 13, 1934, L. Sobczak found 24" high Cedar post in good condition. No BTs. Corner is located at edge of swamp, in slash.

October 20, 1983, Alan Harrison found 4" squared Cedar post with metal tag, from which bears: Turned-out Cedar, S.40°E., 2.6'; Hemlock stump, N.50°W., 7.3'; Hemlock stump, N.16°E., 17.2'

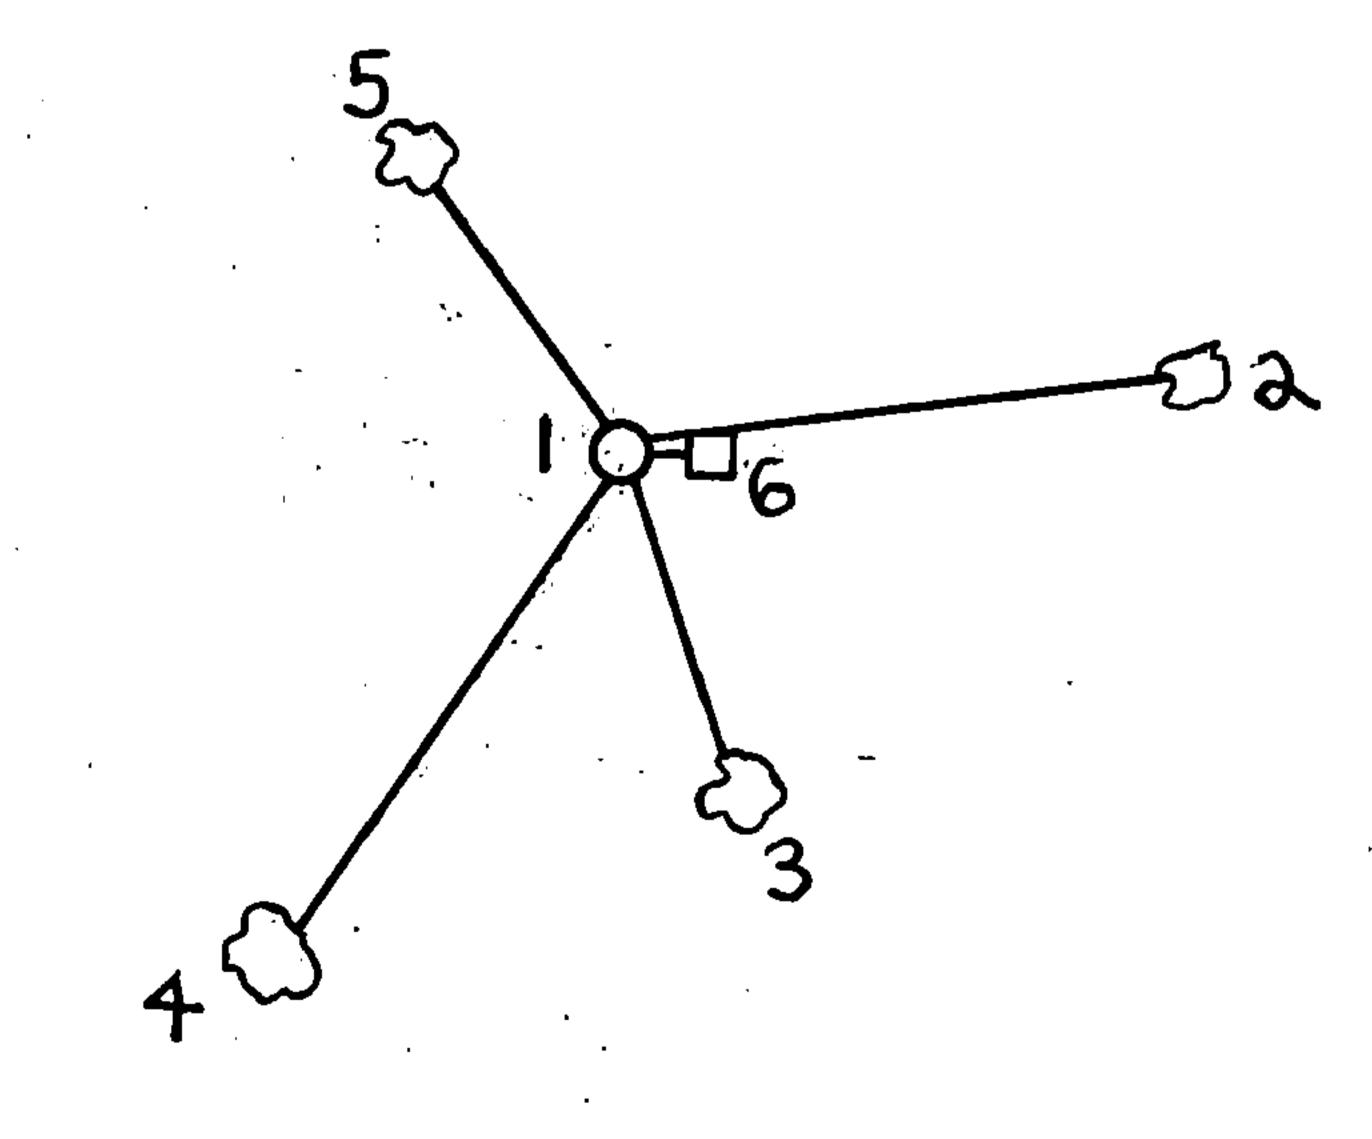
- (c) In the plan view drawing below, provide reference ties to at least 4 witness monuments, or, if the location is within a municipality, to at least 2 witness monuments. (Witness monuments shall be made of concrete, natural stone, iron or other equally durable material.) Describe witness monuments.
- Show a plan view drawing depicting the relevant monuments and reference ties which is sufficient in detail to enable accurate relocation of the corner monument if the corner monument is disturbed. Indicate north.
- 1. 2" x 36" aluminum monument stamped to identify the corner.
- 2. Black Ash, 5", N.86°E., 42.06'
- Black Cherry, 5", S.10°E., 36.34'
- Sugar, 5", S.26°W., 60.51'
- Black Ash, 4", N.23°W., 27.95'
- Steel Sign Post, East, 1.2'
