U. S. PUBLIC LAND SURVEY MONUMENT RECORD

Quarter Corner to Sections 11 and 12, T.37N., R.13E.

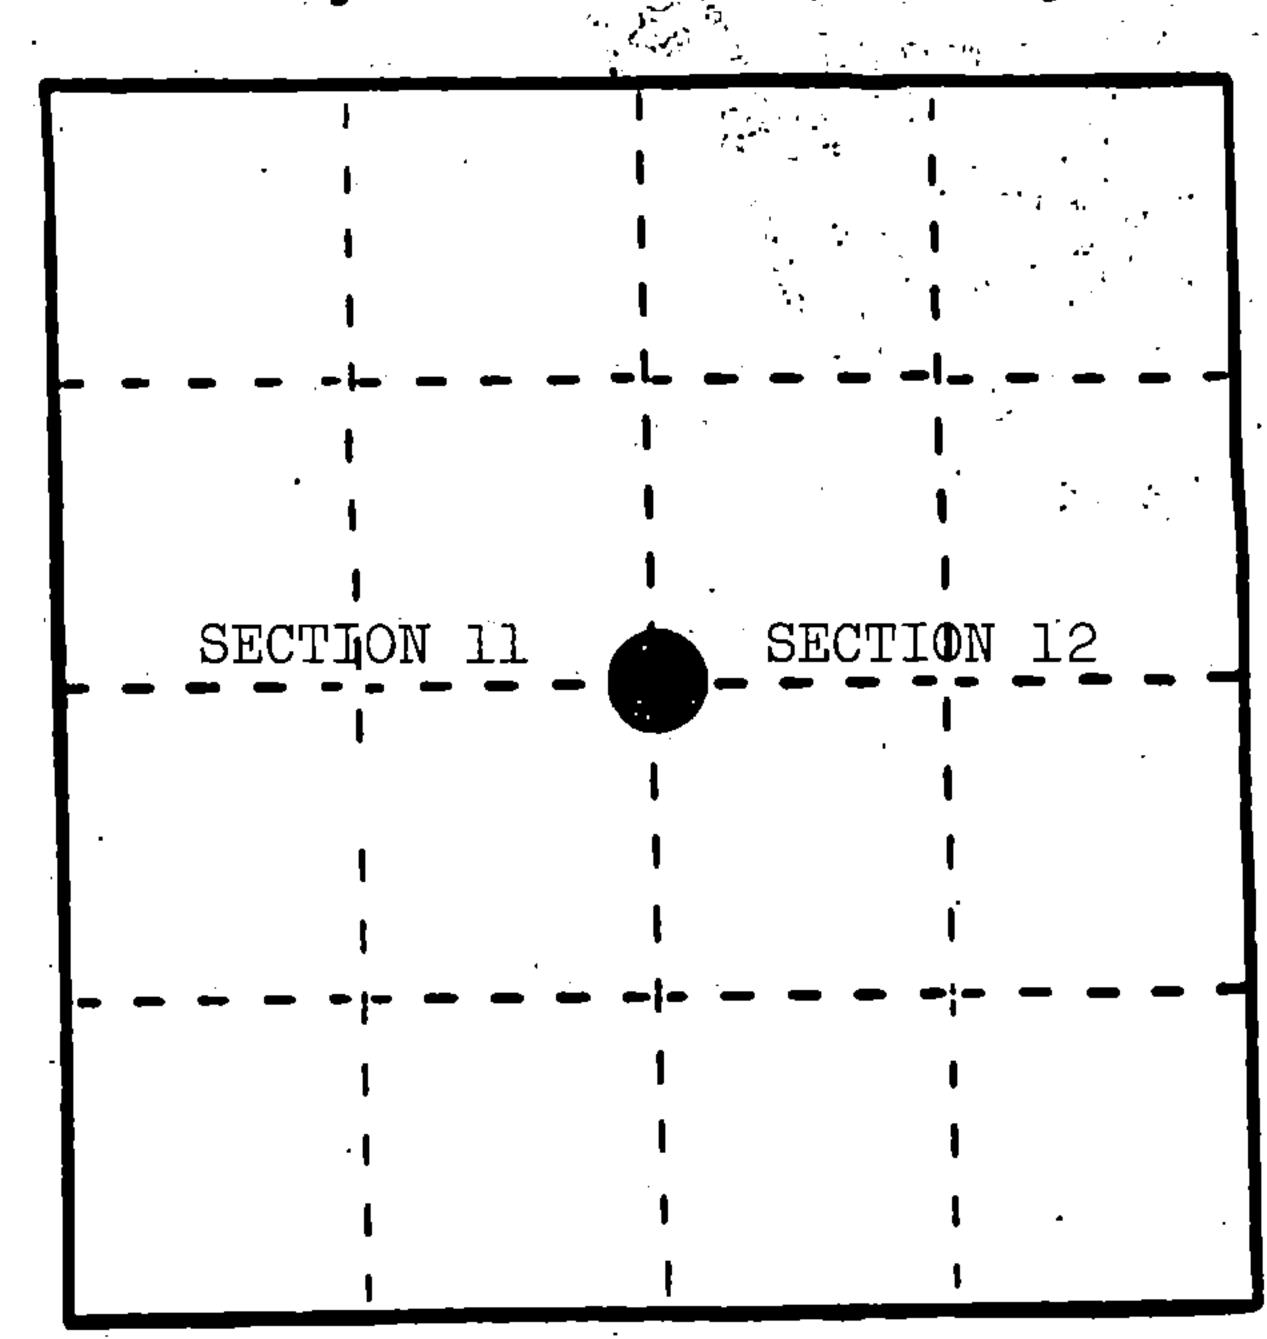
June 19, 1985, Alan Harrison found position as per Neider. Area is in Aspen regeneration. No evidence of original BTs. Accepted post hole as best available evidence of corner position. It appears this fits farm corners in Section 21 by photo interpretation.

Describe witness monuments.
- (d) Show a plan view drawing depicting the relevant monuments and reference ties which is sufficient in detail to enable accurate relocation of the corner monument if the corner monument is disturbed. Indicate north.
- 1. 2" x 36" aluminum monument, in a mound of stone, stamped to identify the corner.
- 2. Red Maple, 6", S.55°W., 63.12 feet
- 3. Cedar stub, 10", S.80°W., 15.14 feet
- 4. Red Maple, 7", West, 82.44 feet
- 5. Steel Sign Post, Northeast, 3.1 feet
