U. S. PUBLIC LAND SURVEY MONUMENT RECORD

Standard section corner to Sections 31 and 32, T.31N., R.15E. and meander corner, east bank of Wolf River.

S.E. COR. SECT 31 T31N R15E

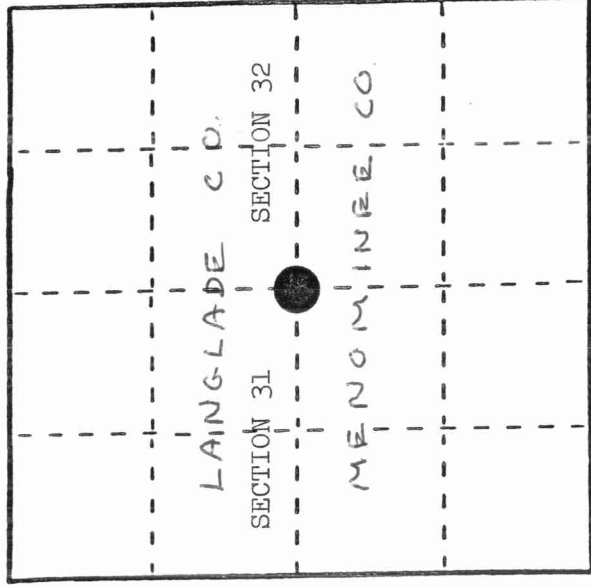
In 1851, James Marsh set meander corner with the following BTs: White Pine, 10", N.31°E., 56 links; White Pine, 18", N.20°E., 45 links; Hemlock, 10", N.16°E., 42 links; Elm, 12", N.9°W., 74 links.

In 1933, Guy Veals--dependent resurvey set from original BTs and at 40.10 chains a 6" x 24" concrete post and new BTs: Rock Elm, 28", N.11°E., 115 links; Elm, 16", N.53°W., 186 links.

In 1985, Alan Harrison found corner as set by Veals. He made new references.

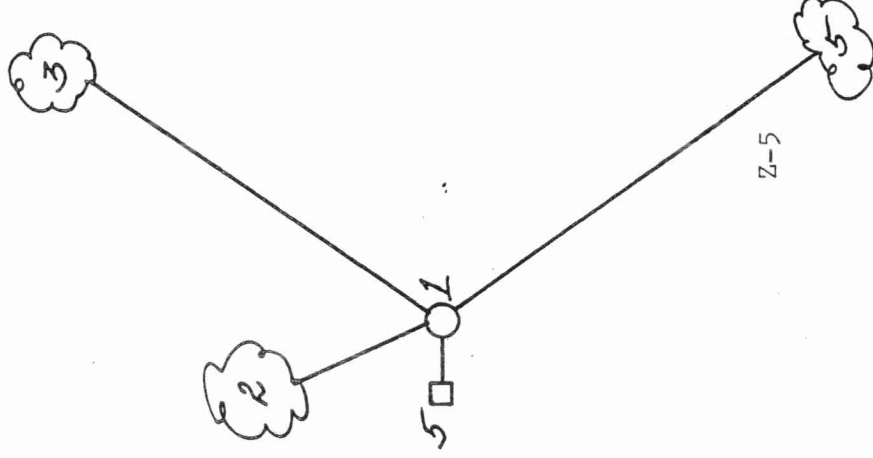
1. 6" x 24" concrete post with brass cap (From 1933 dependent resurvey.)
2. Basswood, 24", N.25°W., 5.87 feet
3. Red Oak, 8", N.27°E., 19.47 feet
4. Cedar, 12", S.34°E., 24.61 feet
5. Steel Sign Post, West, 1.67 feet
