# U. S. PUBLIC LAND SURVEY MONUMENT RECORD

Quarter corner to Sections 3-4, T.32N., R14E., Langlade County, Wisconsin.

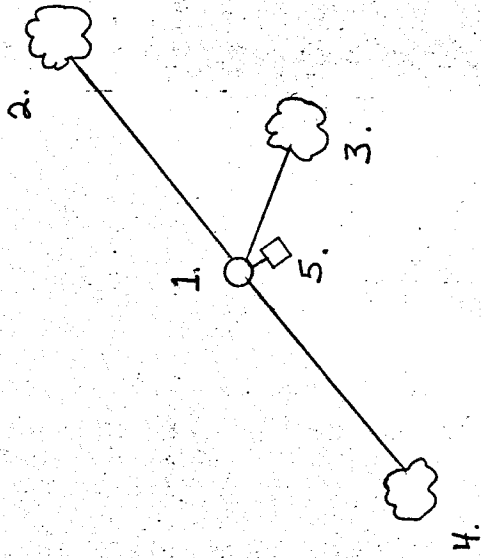
In 1978, Alan Harrison (RLS) found; 2" iron pipe in a mound of rock. Did not find any original or subsequent evidence of bearing trees. Suspect the pipe was set by Connor Lumber Company surveyor. Position of pipe fits distances north and south and is accepted as best available evidence of corner location. Replaced iron pipe with a 2½"x 36" aluminum monument with tablet stamped to identify the corner.

1. 2½"x 36" aluminum monument with tablet stamped to identify the corner.
2. Sugar, 9", N.57E., 31.21 feet
3. Sugar, 7", S.72E., 12.87 feet
4. Sugar, 6", S.56W., 32.63 feet
5. Steel Sign Post, S.E., 1.43 feet
