CERTIFIED LAND CORNER RESTORATION

33-13

Index No. R-11

PLSS field condition report

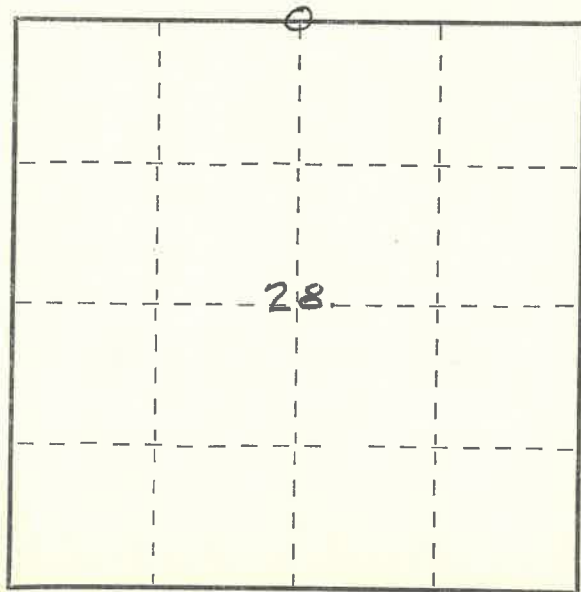
SET 2" IRON W/BRASS CAP, MKD N 1/4 COR SEC. 28

○ = Corner monument restored.

- 1- HEMK STUMP 16 S80°E 30.5' W/ST. MK VERY OLD.
 - 2- MAPLE H. G S75E 18.6'
 - 3- Y. BIRCH W/OLD BLAZE S13°-30E 14.0
 - 4- Y. BIRCH 12 S55-30W 19.4'
 - 5- STUMP- HEMK. W/BLAZE 16 N70W 28.0'
 - 6- HEMK W/ SCARS 8 N64°-30' E 10.0'
- TREES 2, 4, 6 BLAZED & SCRIBED NBT.

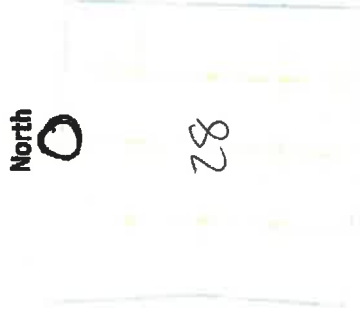
Section 28 Town 33N Range 13E
(circle corner location on diagram)

Does the monument appear to be tilted, smashed, uprooted, covered or otherwise damaged by the windstorm?
YES NO 2" iron without brass cap was undamaged

Could not locate 2" pipe w/ brass cap.
Are any bearing trees broken, uprooted, missing or otherwise damaged by the windstorm? YES NO

#Found 2" iron pipe, no brass cap, corner could be covered by blown down tree tops.
