U S PUBLIC LAND SURVEY MONUMENT RECORD - ADDENDUM

A-E 7.08(3)(a) Identity of corner  
SOUTHEAST CORNER OF SECTION 27  
TOWNSHIP 34 NORTH  
RANGE 11 EAST OF THE 4TH PM  
TOWN OF ELCHO,  
COUNTY OF LANGLADE

# CERTIFIED LAND CORNER RESTORATION

Index No. V-17

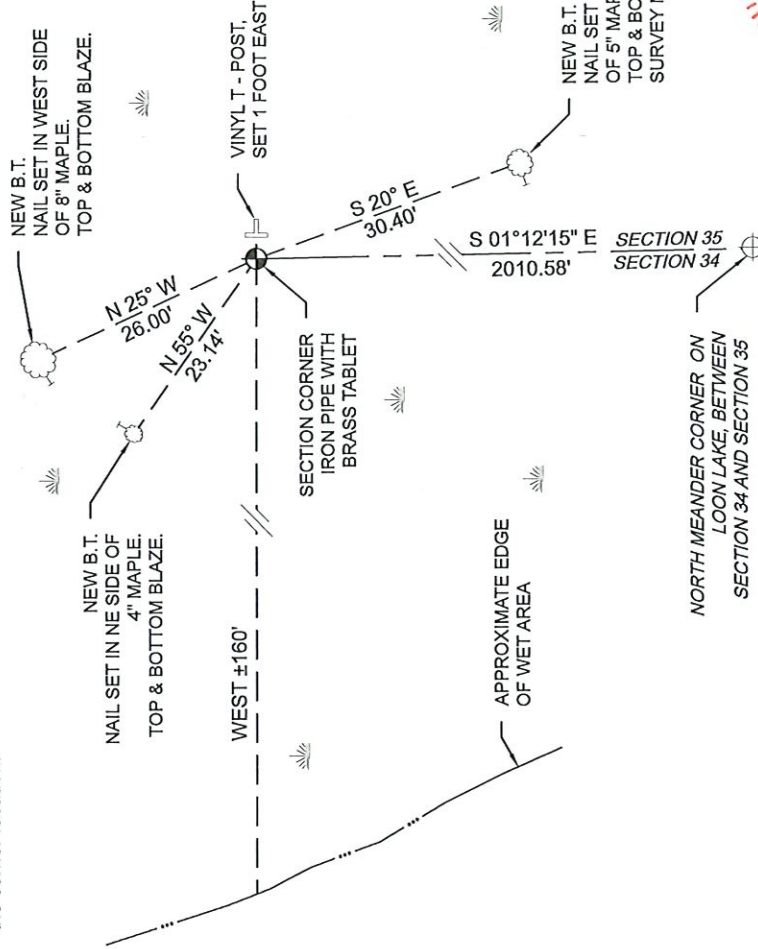
November 16, 2021 - I found a 2 1/4" diameter iron pipe with a 2 1/2" brass tablet affixed to the top & stamped to identify the corner. Monument was leaning southeast, in a wet area with heavy wind fallen trees. I straightened the monument and pounded it to ±0.5' above grade.

I accept this monument as a FOUND PERPETUATED LOCATION OF THE CORNER and established 3 new witnesses as shown below.

A-E 7.08(3)(c)(d)(e)(h) Plan view of corner with references to at least 4 witness monuments. If in disagreement with previously established corner, show the distances between the two corners and also indicate the ties to the disputed. The directions and distances to other public land survey corners used as evidence or used for determining the corner location.

BEARINGS LISTED TO THE NEAREST SECOND ARE REFERENCED TO WISCONSIN COUNTY COORDINATE REFERENCE SYSTEM - LANGLADE COUNTY ZONE. ALL OTHER BEARINGS ARE MAGNETIC.

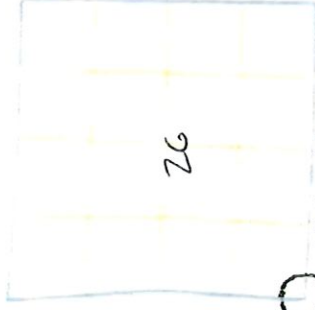
North

☒ YES NO A large birch tree was uprooted immediately adjacent to monument, causing the monument to tilt.

damaged by the windstorm? ☒ YES NO No bearing trees were found, but severe damage

occurred at corner location. Several white birch and balsam were down near where

TAKE PICTURES they were described on tie sheet.

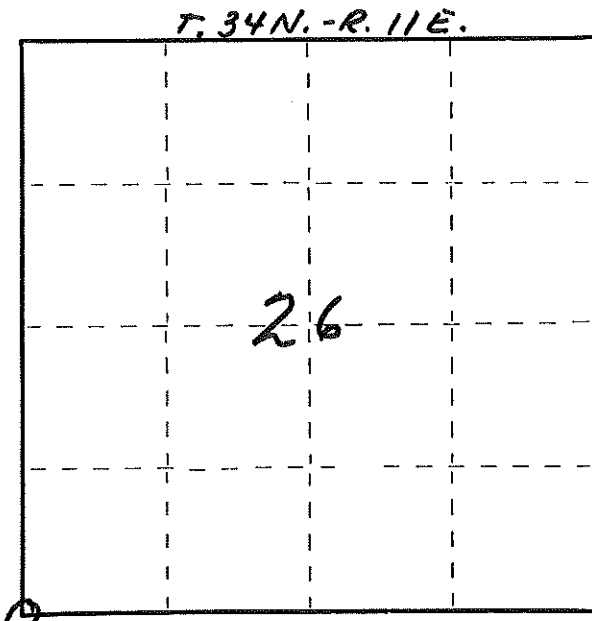
○ = Corner monument restored.

LOCATED S.W. CORNER SECTION 26 T. 34 N. - R. 11 E. - 4" CEDAR POST IN SWAMP. FOUND ONE SCRIBED BEARING TREE.

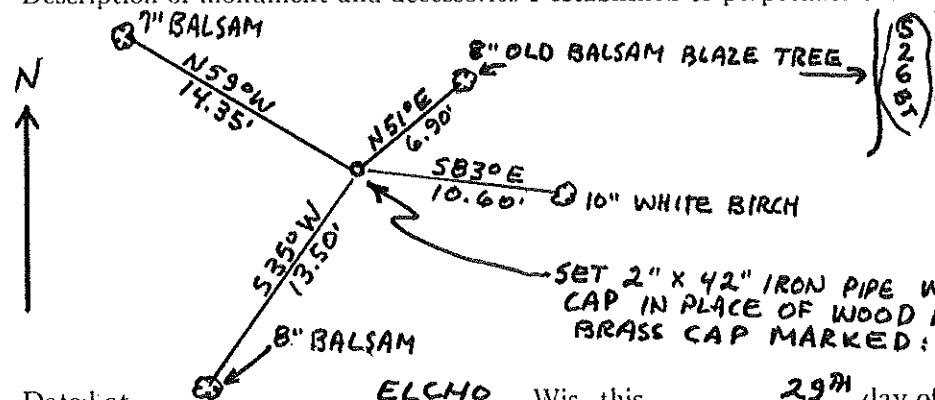
Description of monument and accessories I established to perpetuate the original location of this corner.

SCRIBED NEW BEARING TREES: ✓
